Final Report of the VA Research Infrastructure Program

Veterans Health Administration
Office of Research and Development
July 2012

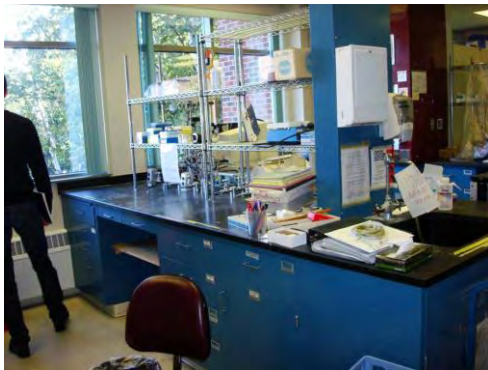
Typical laboratory in Bldg 44.

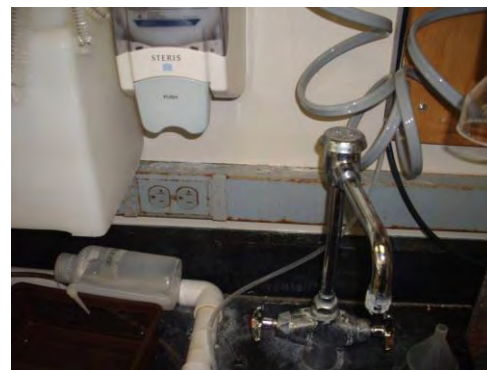
Receptacles near sinks are not ground fault protected. Also note the rusted electrical raceway.

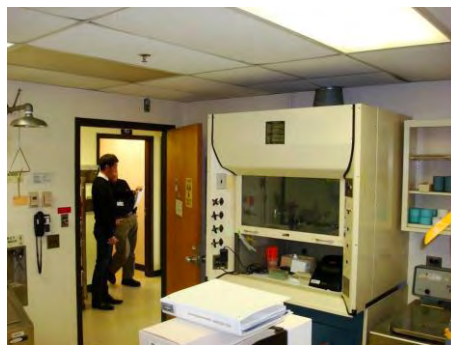
Fume hood blocking laboratory egress, Bldg T-44.

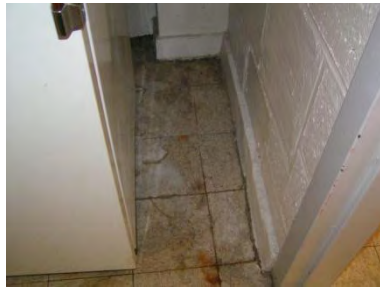
Flooring throughout Bldg 17 is damaged.

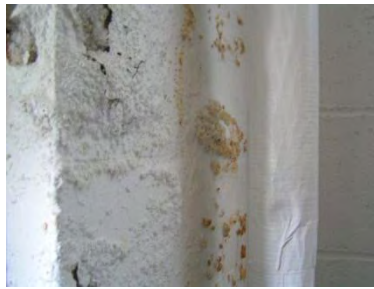
Mold growing in a Bldg 17 laboratory.

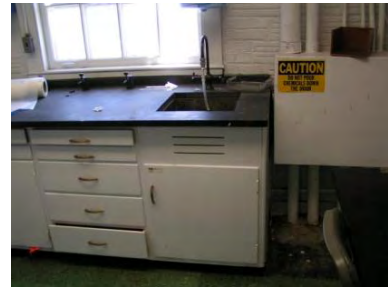
Typical laboratory casework, Bldg 17.

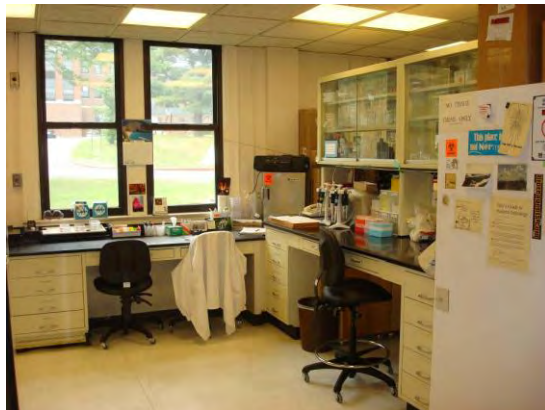
Overall, the laboratories in Bldg 18 are significantly better than in Bldg 17.

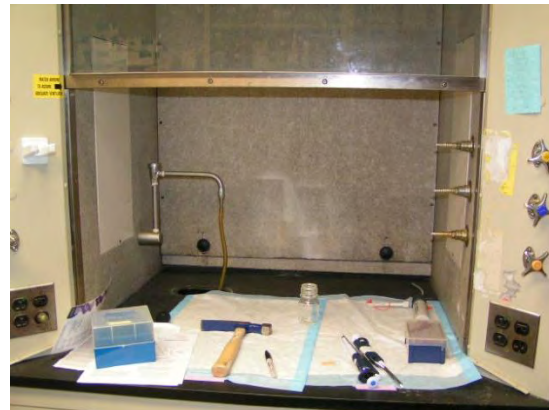
Asbestos lined fume hood in second floor laboratory.

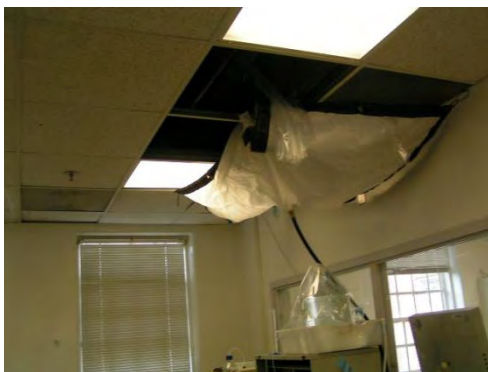
A temporary solution to leakage in a Bldg 70 laboratory. The roof leaks resulting in extensive interior damage.

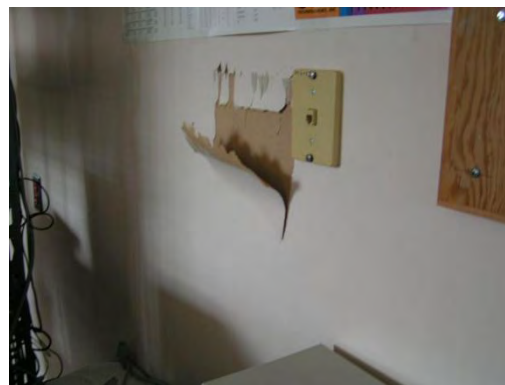
Damage to wall finish caused by water leakage.

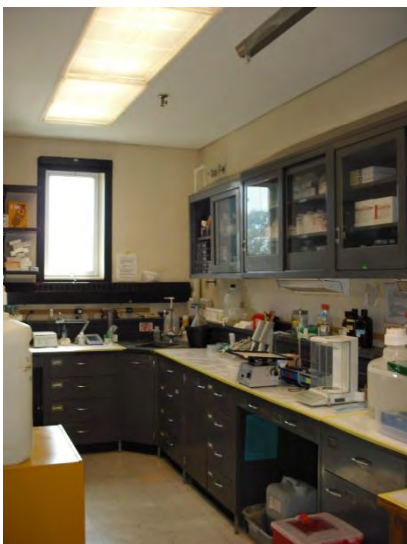
Typical laboratory casework in Bldg 1A.

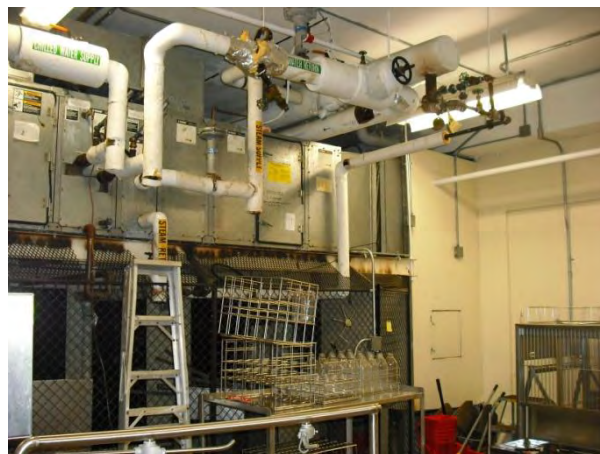
In the VMU, there is no wall between the cage washer and HVAC equipment.

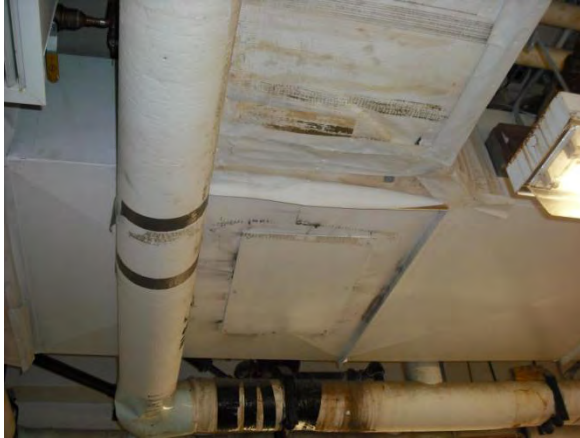
The cage wash area in Bldg 7 has an inappropriate ceiling.

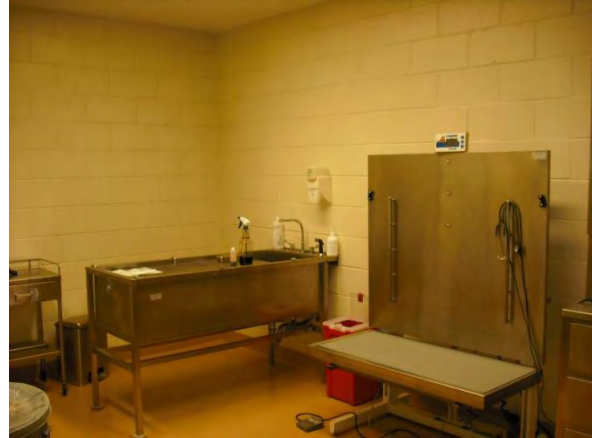
A prep/treatment room in the VMU.

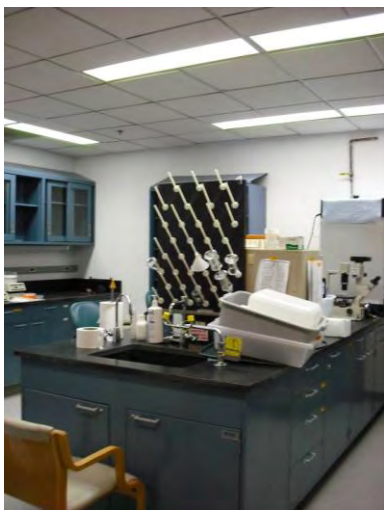
Laboratories in Bldg 3 are aesthetically pleasing.

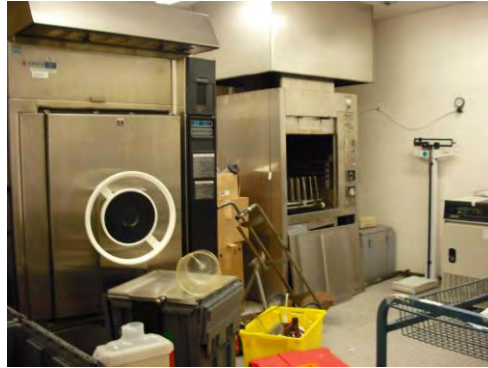
The autoclave and glassware washer in Bldg 3 are in fair condition, but are reaching the end of their useful lives.

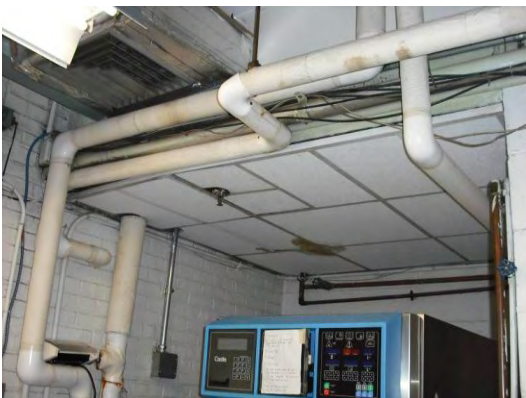
An inappropriate ceiling in the autoclave room, Bldg 20.

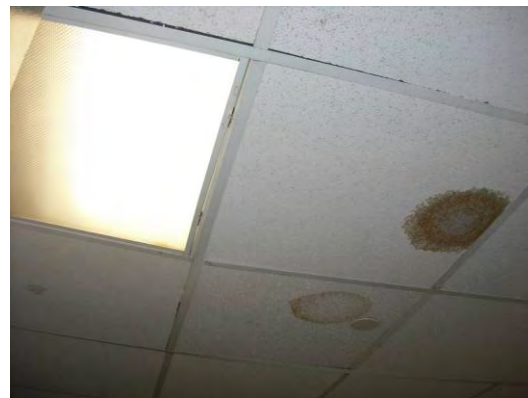
VMU space should have hard ceilings, not acoustic tile. This tile ceiling is damaged. Also note the lack of a gasket on the lighting fixture.

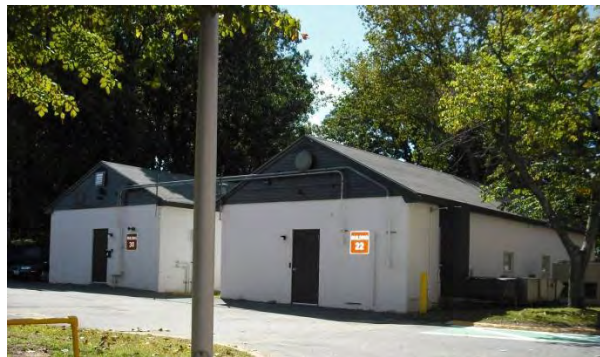
The exterior of Bldgs 22 and 30, two Quonset huts built in the 1960s and used for animal surgery and procedures. Both buildings are slated for demolition.

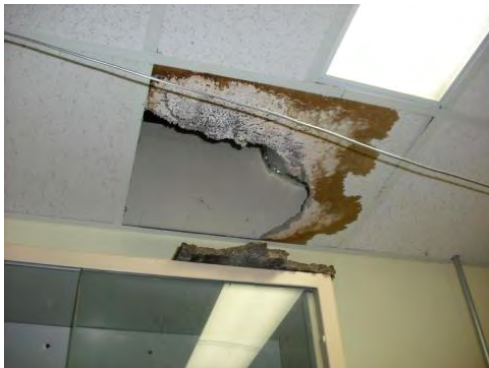
Ceiling damage in Bldg 44.

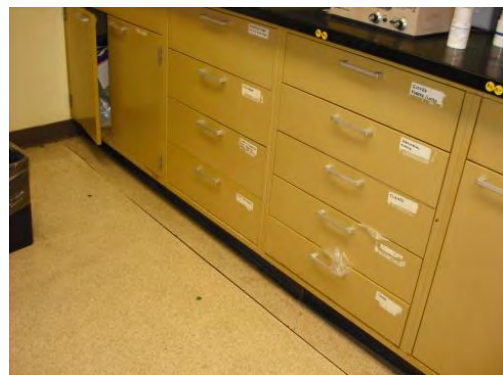
Damaged flooring and rusted casework in Bldg 44.

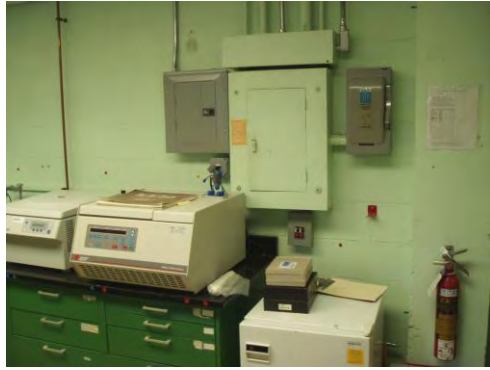
Access to electric panel blocked by equipment in Bldg 44.

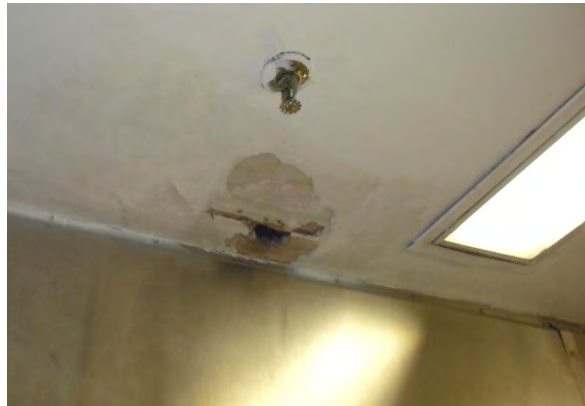
In Bldg 46, damage to an animal holding room ceiling.

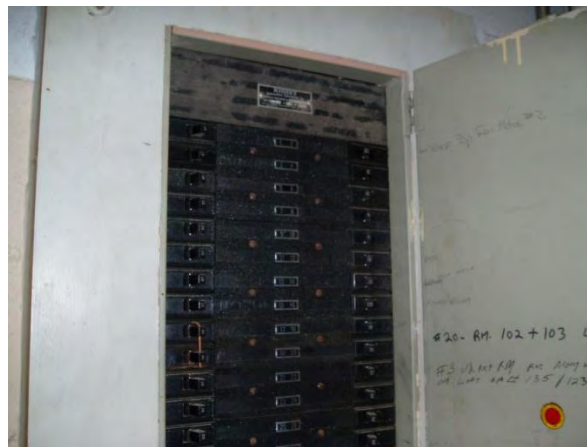
Old style electrical panel in Bldg 46.

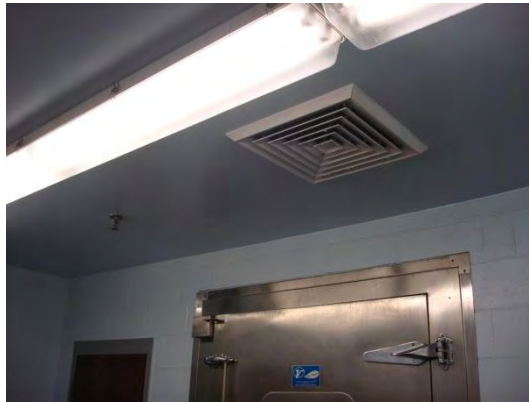
Left photo: There is no exhaust canopy over the cage washer to catch steam when the cycle is complete and the door opened. This will result in damage to finishes within the cage wash area.

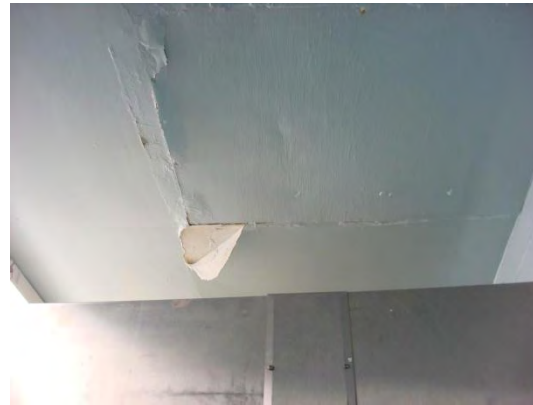
Right photo: The ceiling in the cage wash area is already showing damage from excess steam filling the room.

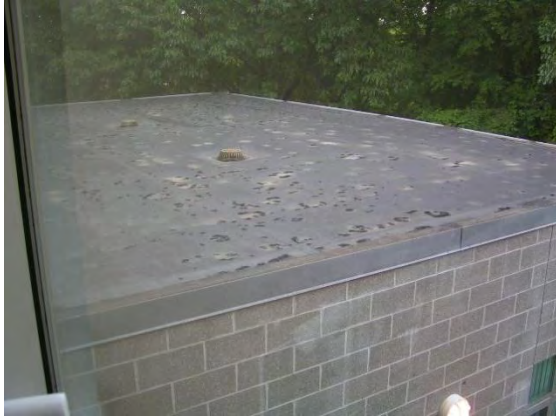
At the time of the assessment, the roof on Bldg 35 had significant leakage.

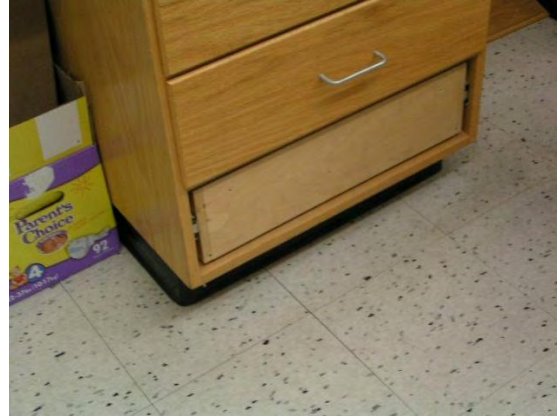
The wood casework in Bldg 35 is not of an appropriate quality for use in research laboratories.

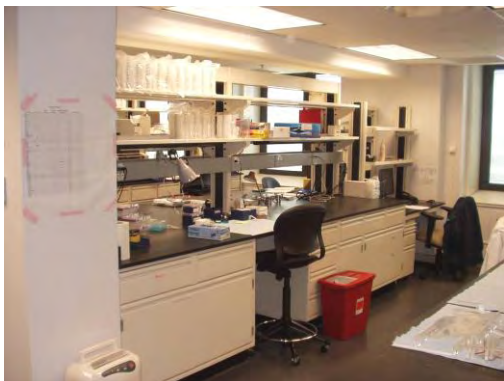
This is typical of a renovated laboratory in Building 2.

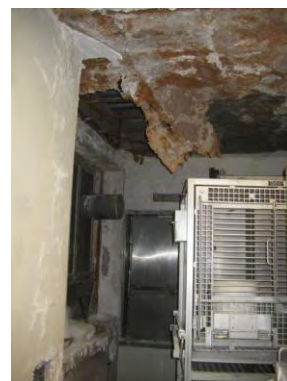
This space on the first floor that has been severely water damaged will be renovated to house freezers.

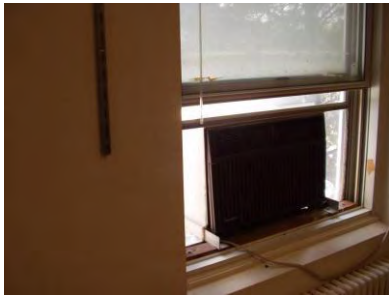
Window AC units are used to cool laboratories in Bldg 3.

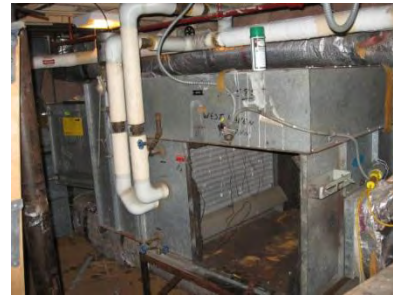
This air handling unit in Bldg 3 was in failing condition at the time of the assessment.

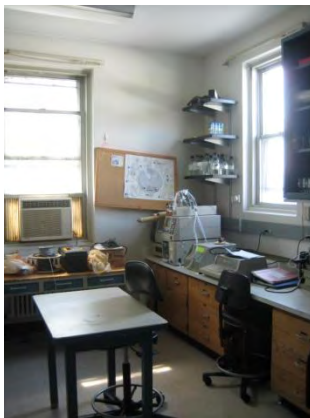
An outdated laboratory in Building 4.

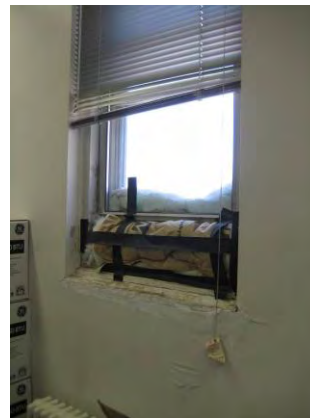
Damage at a laboratory window, Building 5.

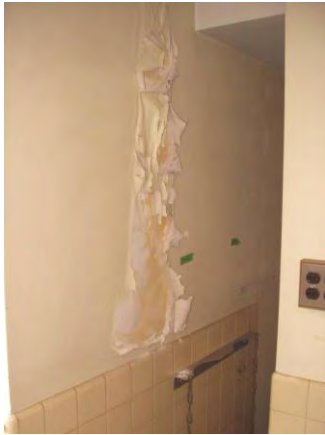
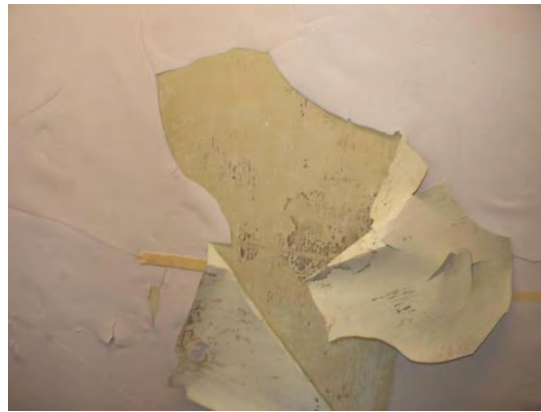
Examples of water damage to walls and ceiling in Building 7.

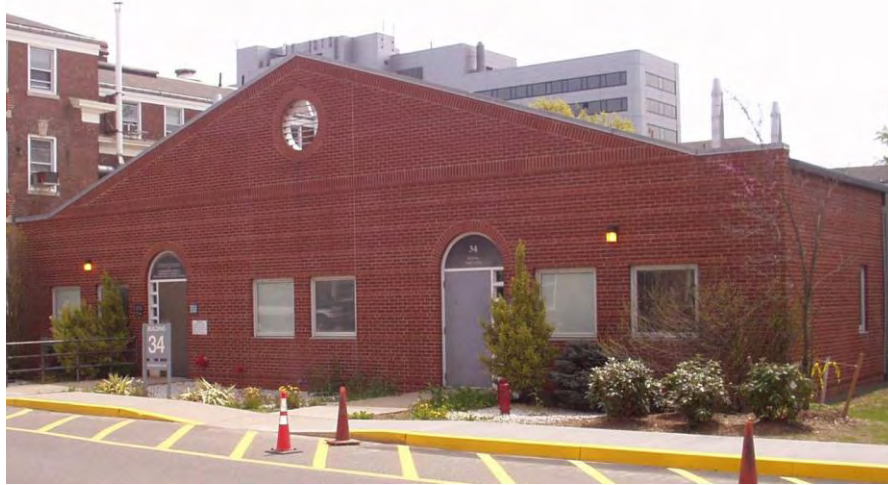
Constructed in 1986 with a recent addition, Bldgs 34/34A are welcome additions to the West Haven VAMC campus.

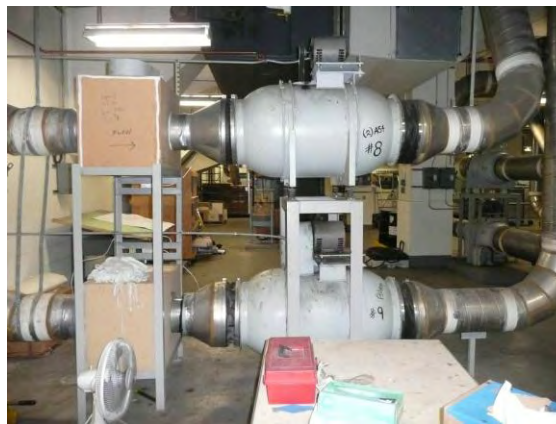
The entire third floor of Building 20 houses mechanical and utility space, protecting equipment from the elements. Shown here are inline fume hood exhaust fans with inlet HEPA cabinets.

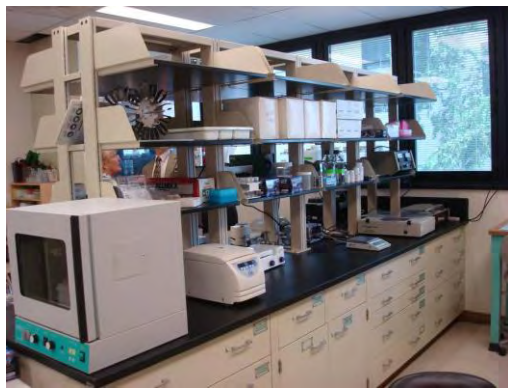
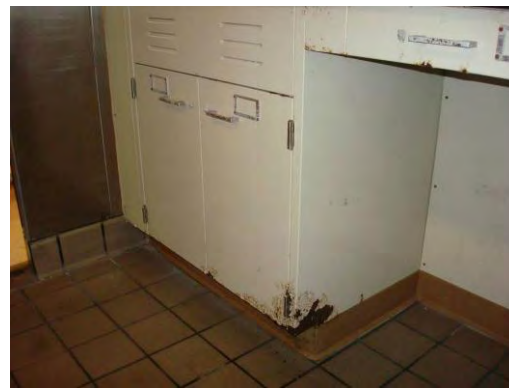
Left photo: Most laboratory casework is in good condition. However, some have base cabinets with corrosion (right photo) and drawers that are difficult to open.

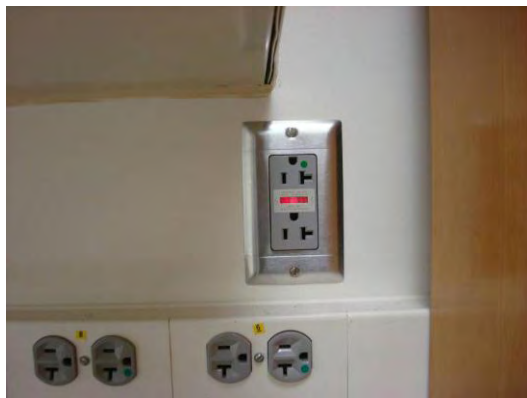
A receptacle protected with transient voltage surge suppression (TVSS).

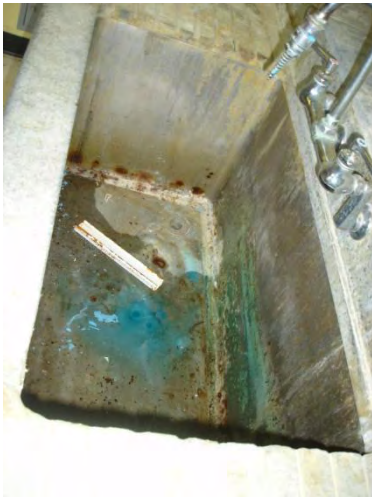
Several laboratories have badly corroded sinks.

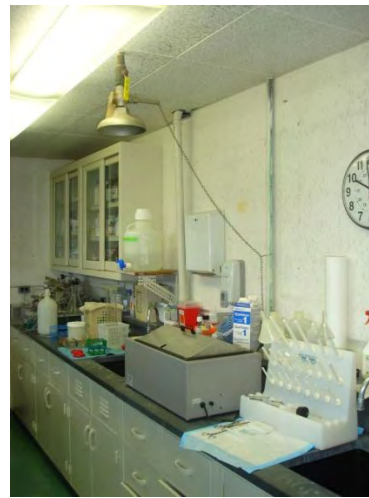
Inaccessible safety shower with equipment requiring electricity below. Safety shower deficiencies have been corrected.

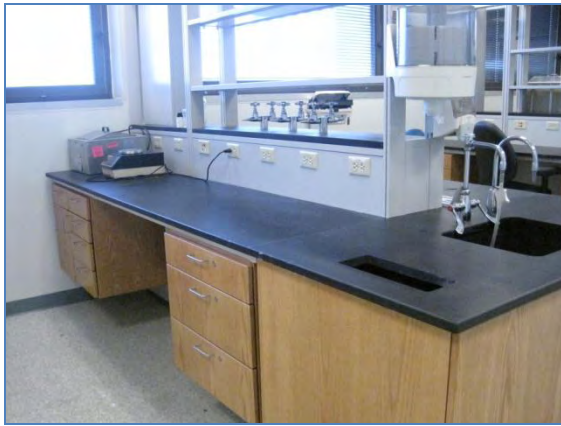
Left photo: A renovated laboratory. Note the odd cut out area adjacent to the sink which has no apparent purpose. The right photo shows a laboratory that has not yet been renovated.

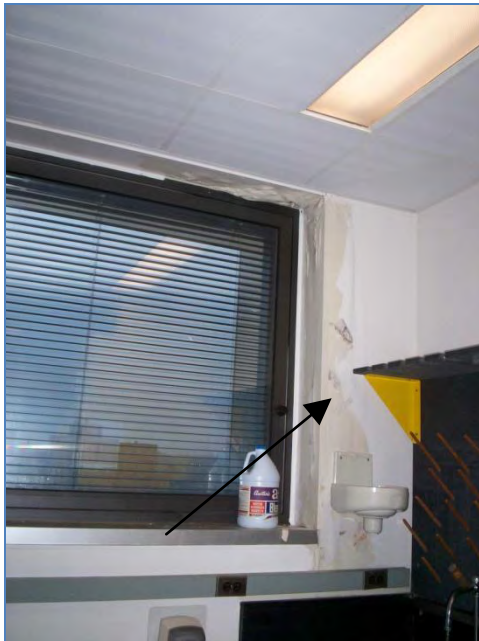
Water leakage around windows has caused significant damage to finishes.

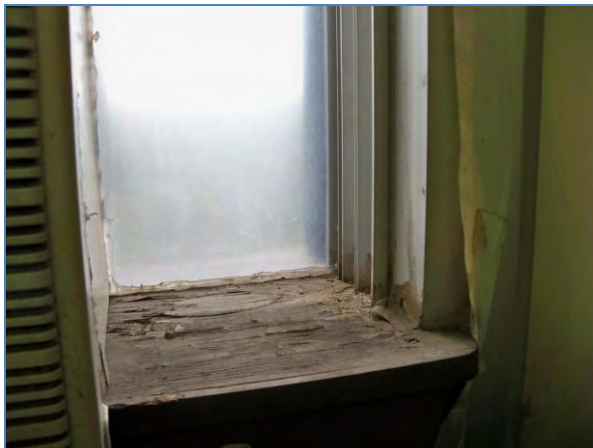
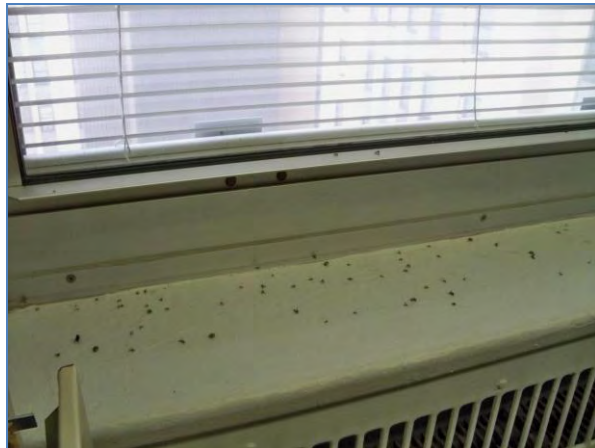
Window and wall conditions in the Building 1 laboratories are generally poor. There also is evidence of insect intrusion on window sills.

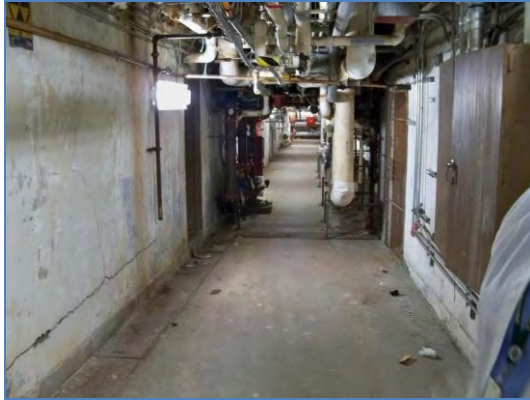
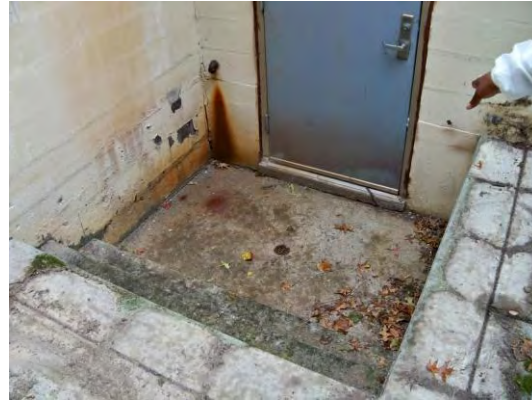
Left photo: The foundation wall in the basement of Building 7 is cracking and showing signs of water pressure from the exterior. At right, an egress door from the VMU where water builds up after it rains.

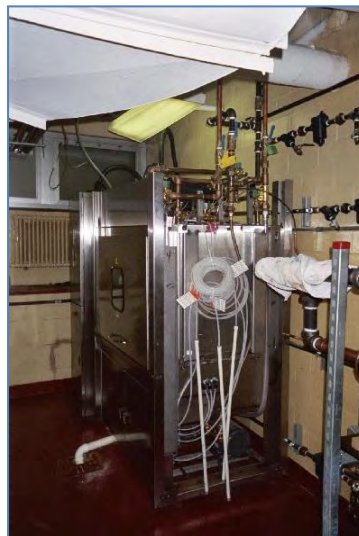
The cage washer in the animal facility.

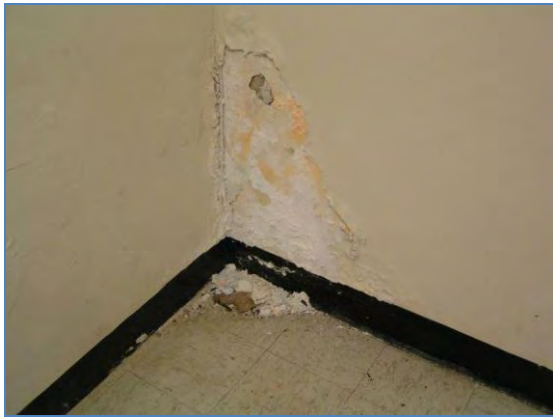
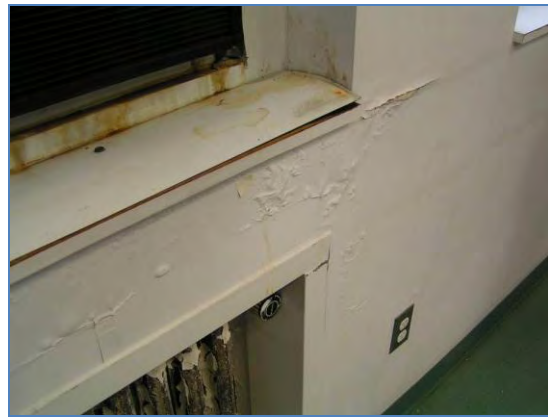
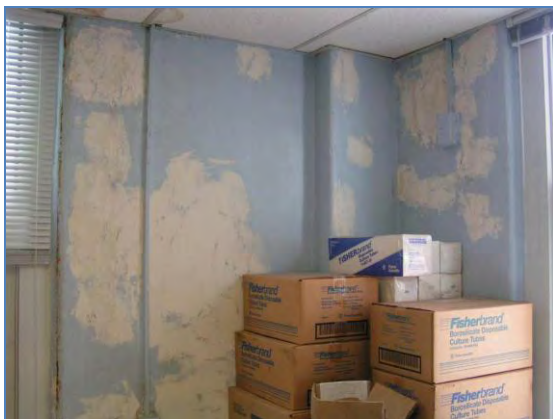
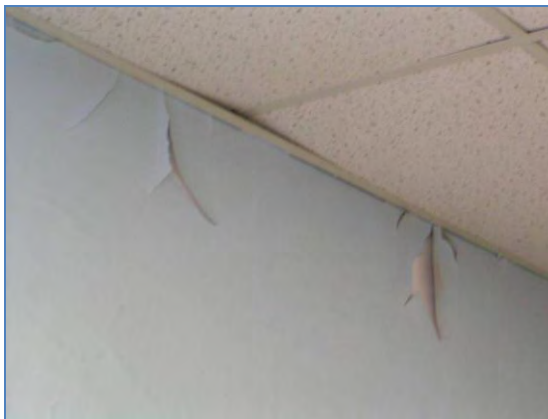
The four photos above show examples of water damaged finishes in Building 61.

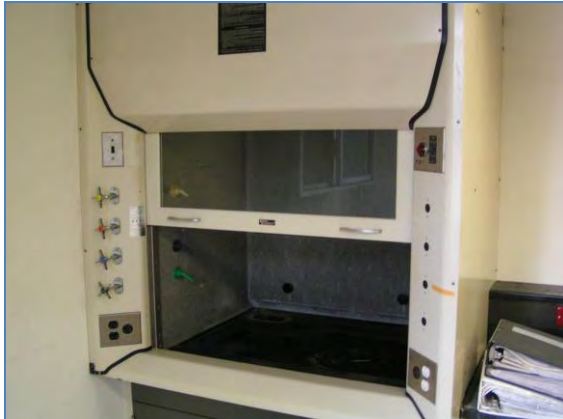
In Building 62, a newer fume hood in a recently renovated laboratory.

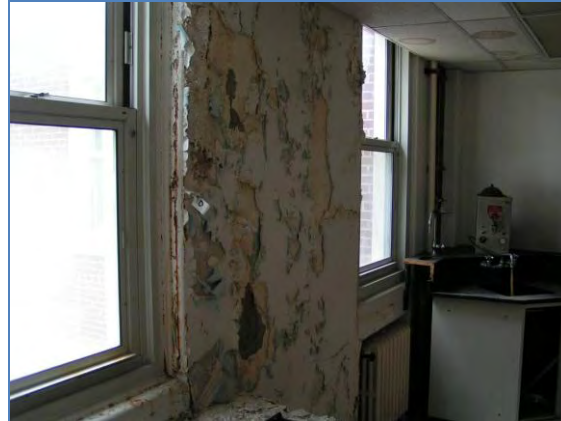
Building 62 also has water damage.

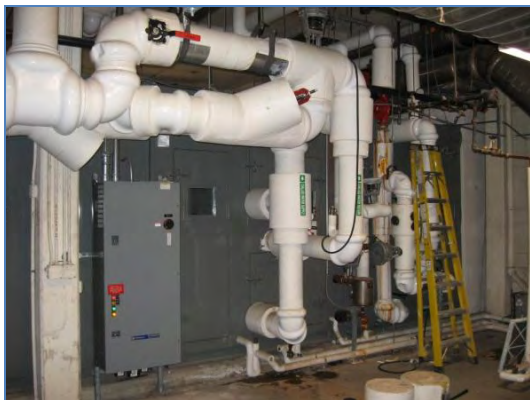
A new air handling unit serving the research space.

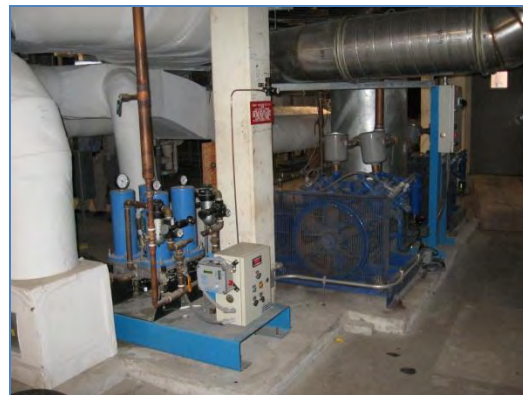
New laboratory vacuum pumps. This station has consistently upgraded systems when renovating laboratories.

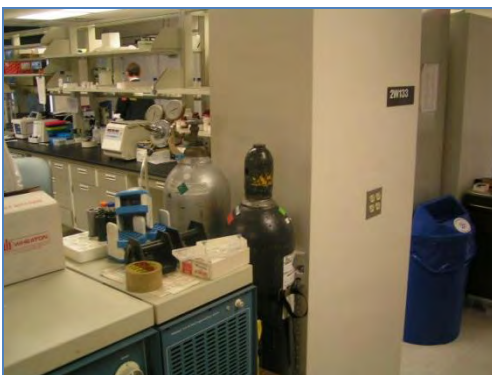
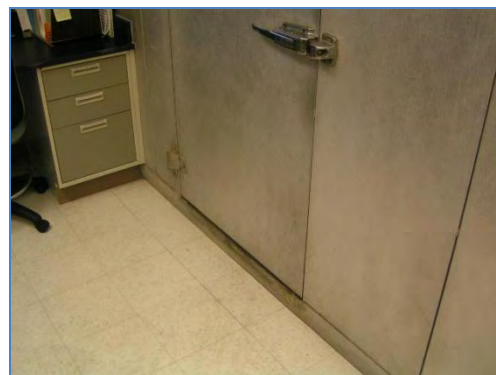
Building 1 research spaces: the left photo shows a recently renovated laboratory. The photo at right shows a cold room that is lacking a ramp for accessibility.

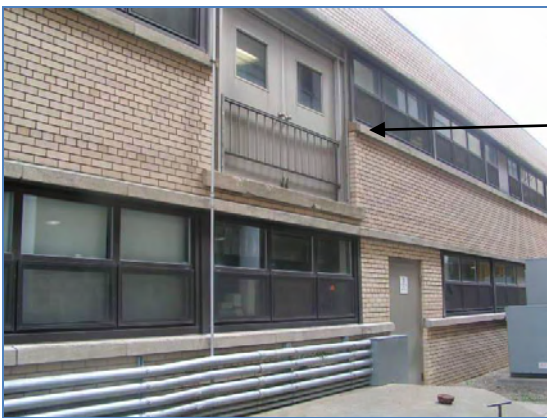
In Building 6 equipment delivered for use on the upper floor must come through this exterior second floor door. There is no elevator in the building.

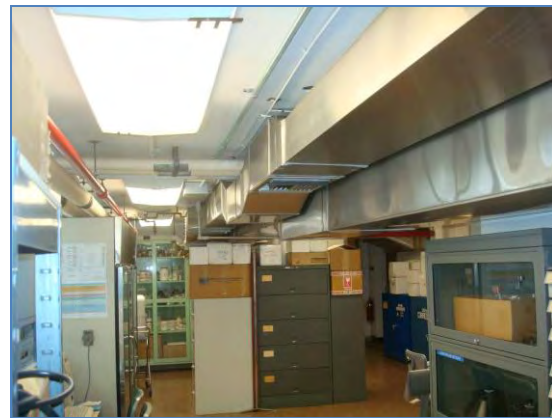
Building 6 has many challenges. This very low exposed ductwork is one of them.

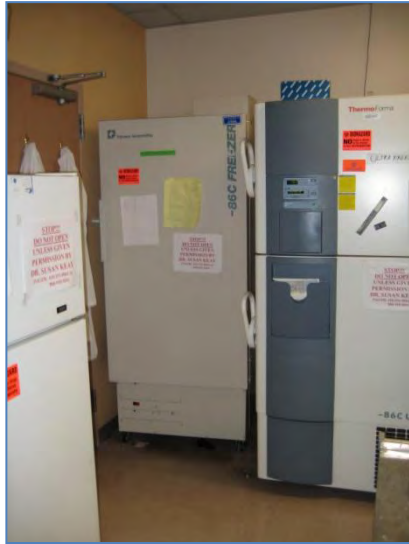
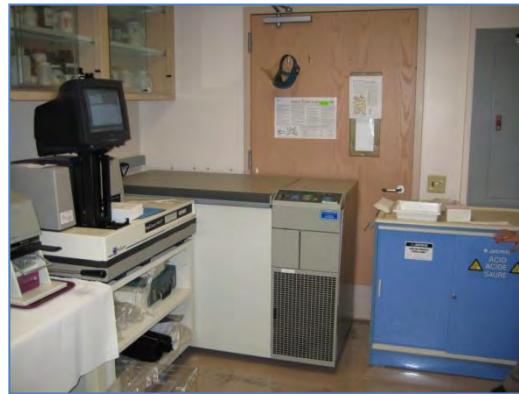
Lack of space for freezers and other large equipment results in crowded laboratories and blocked egress.

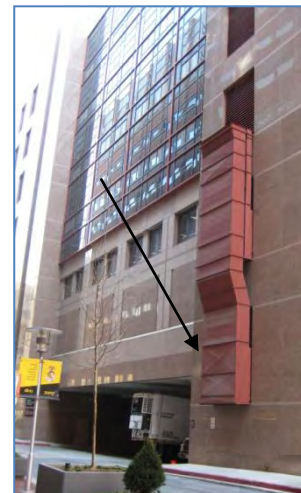
The laboratories have emergency lighting, but the VMU does not. Battery pack emergency lights should be installed in the VMU.

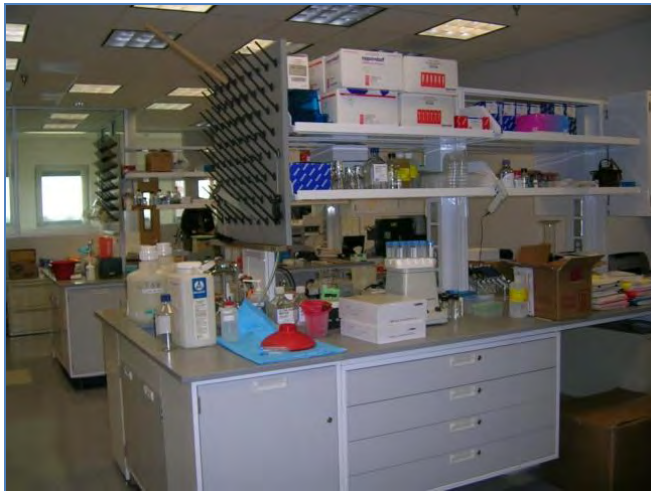
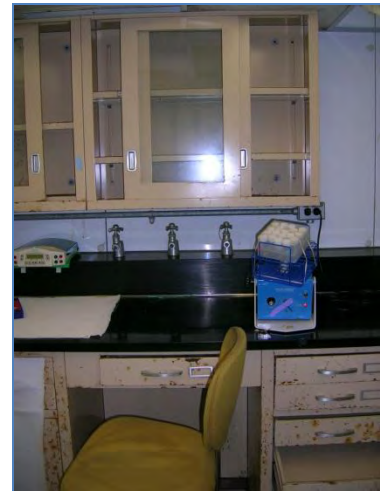
The photo at left shows a recently renovated laboratory. Most of the laboratory space has not been renovated. The photo at right shows casework from a laboratory in need of renovation.

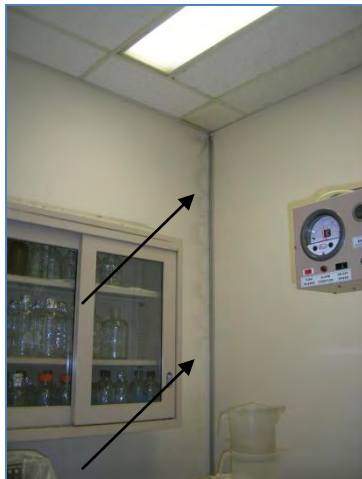
Water damage in a laboratory.

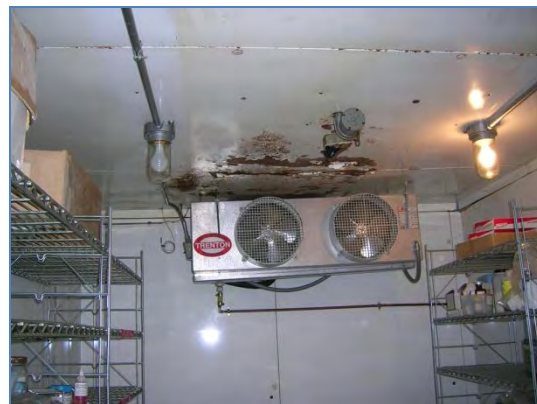
Although this cold room is operational, it has significant physical damage.

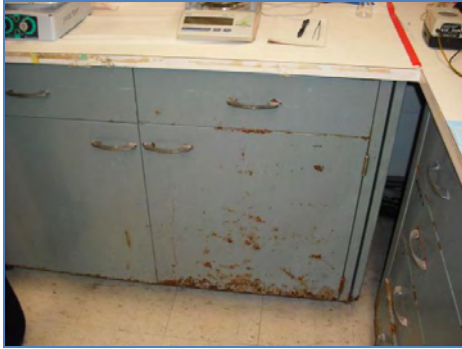
Example of corroded laboratory casework in Building 1.

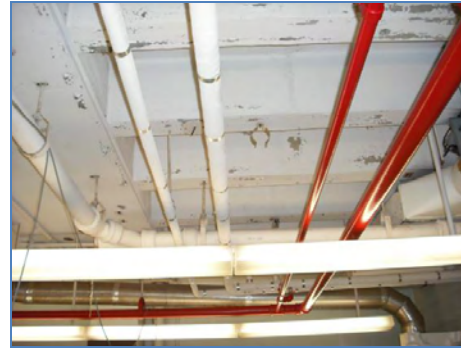
Example of paint peeling from overhead structure in Building 1.

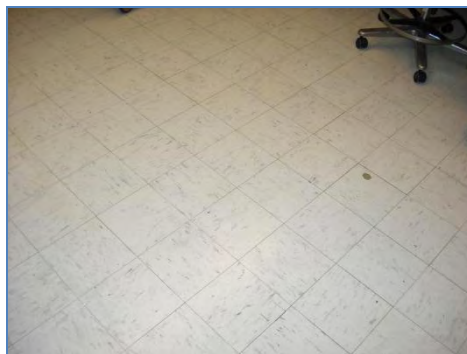
Asbestos flooring in Building 10 has been well maintained.

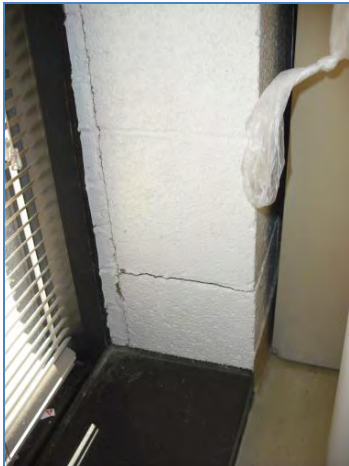
Cracks in exterior wall, Bldg 14.

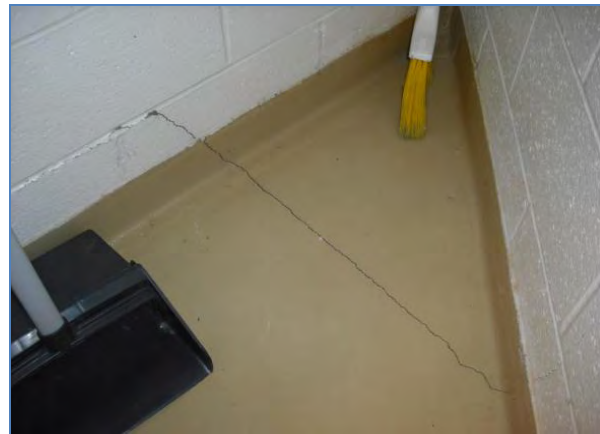
Cracks from the exterior wall across the floor of Building 14.

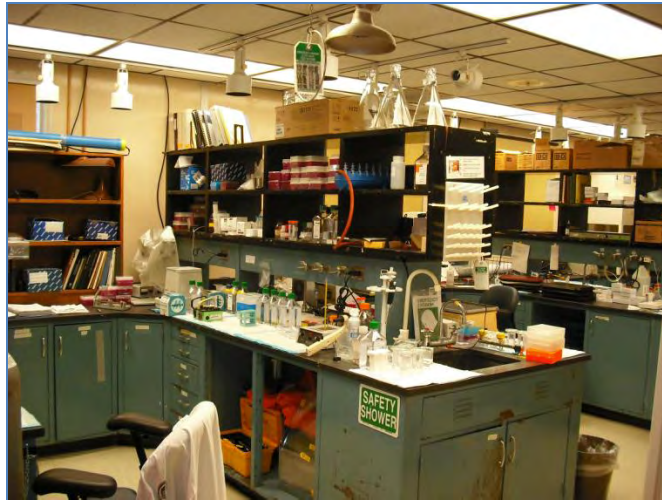
A typical laboratory in Building 16.

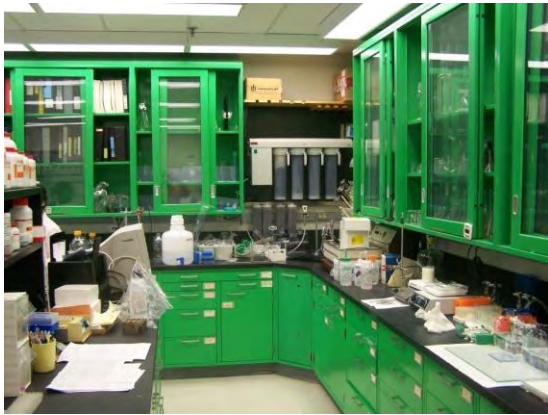
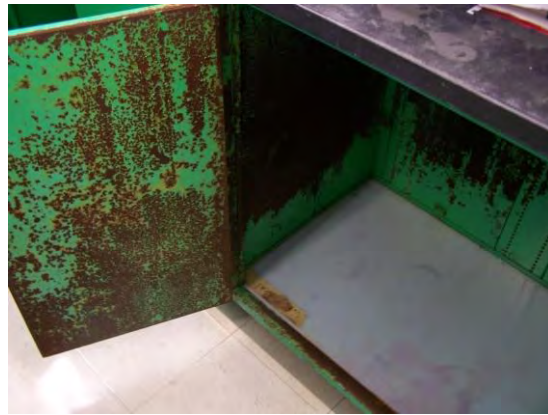
Most laboratory casework is in good to fair condition (left photo) but in some spaces there is severe corrosion in the lower cabinets (right photo).

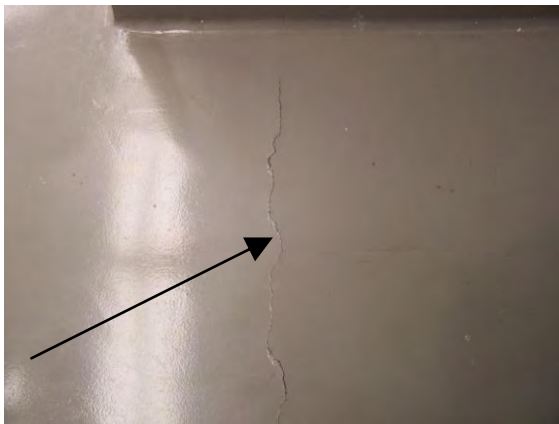
Some cracking has developed in the epoxy flooring in the VMU.

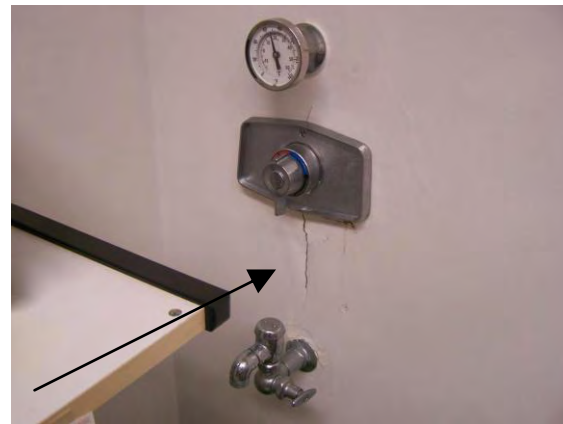
Also in the VMU, this wall behind a faucet has developed cracks.

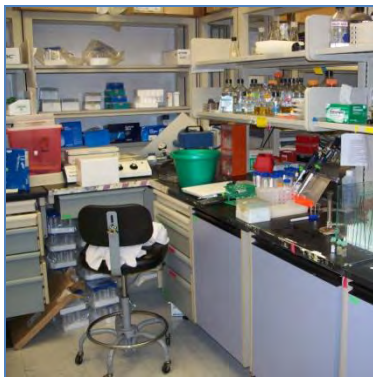
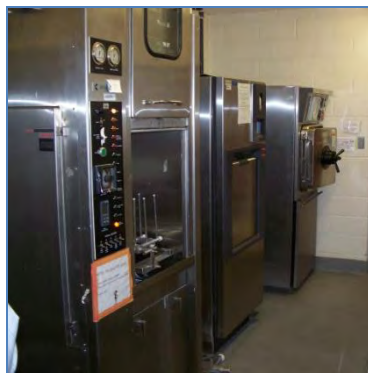
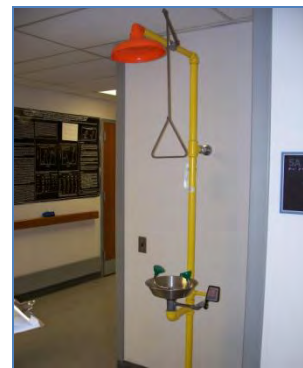
Generally, the laboratories and support spaces in Building A are in good condition including casework and finishes, fixed equipment, and safety requirements.

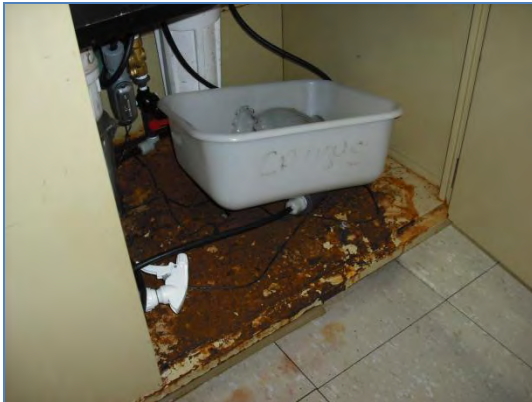
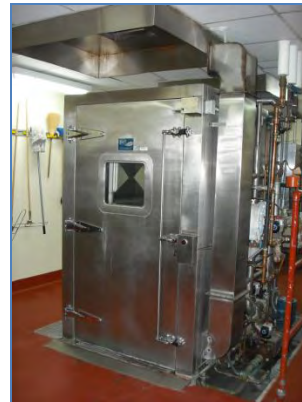
While many of the interior finishes are in good condition overall, the laboratory casework is original to the building and much of it is severely corroded, particularly beneath sinks. The VMU cage washer (right photo) is also original equipment and has frequent breakdowns.

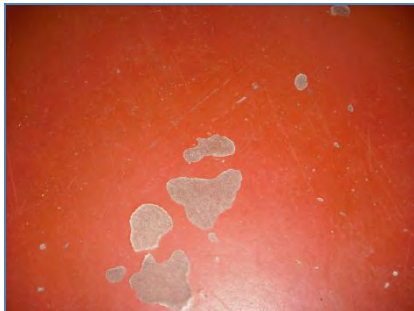
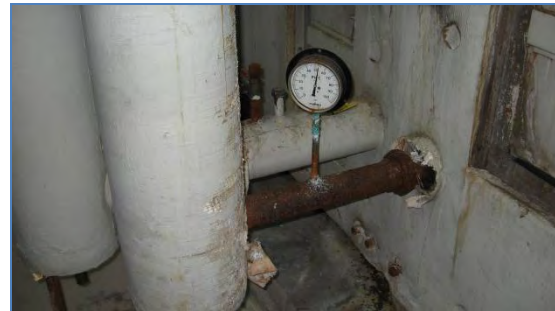
(Left photo): In the VMU, some flooring is damaged. (Right photo): This chilled water pipe is severely rusted.

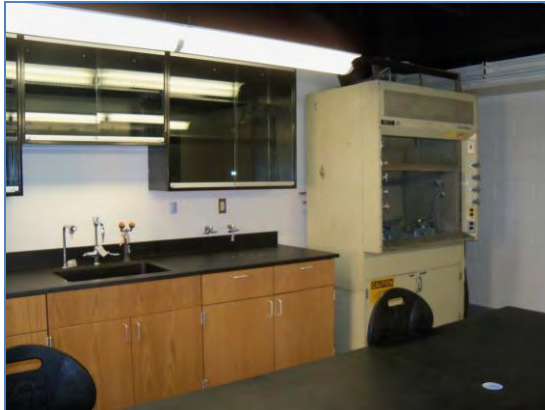
Finishes, casework, and countertops in the newly renovated laboratories are in excellent condition. However, an aging fume hood has been placed in this laboratory.

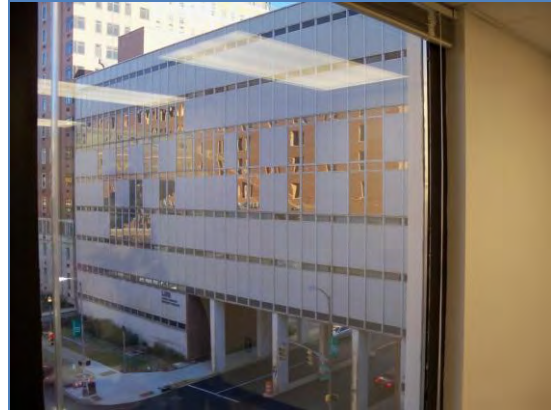
This landlocked VA facility has several "bridge" buildings that are connected to the VAMC and to UAB, above downtown streets. The building above is the Research Wing.

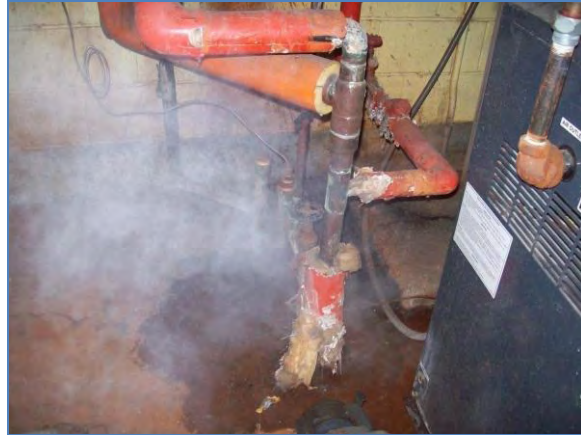
While the laboratories are newly renovated, the building's support systems are severely aging and deficient. The photo at left is the compressed air system in poor condition. At right is a steam leak in mechanical space.

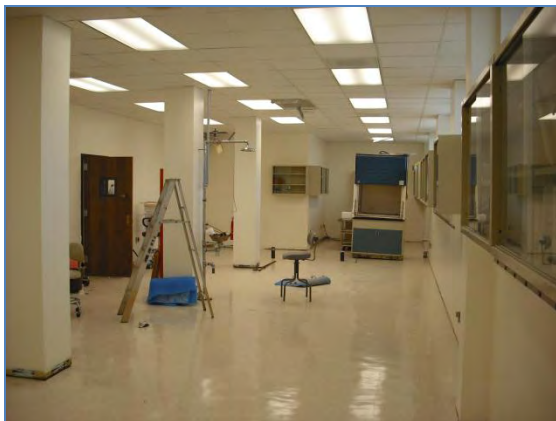
This laboratory space was being renovated at the time of the assessment.

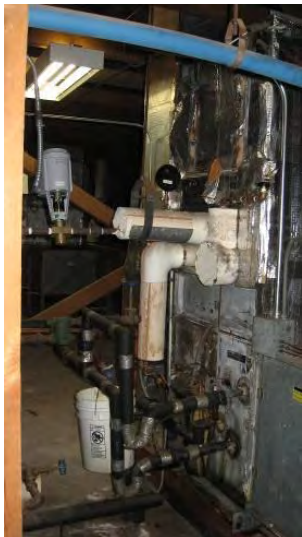
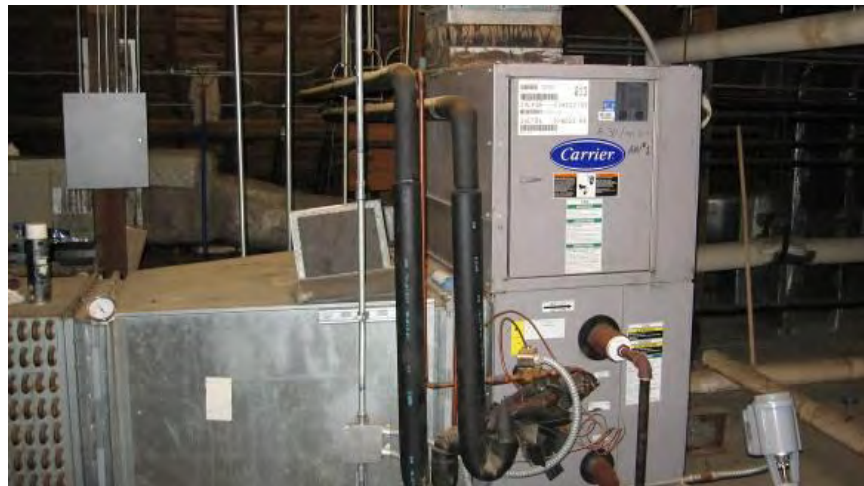
During the assessment, air handling units serving the original part of the building as well as the VMU were found to be in failing condition.

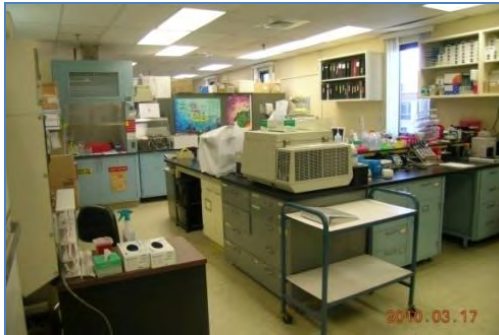
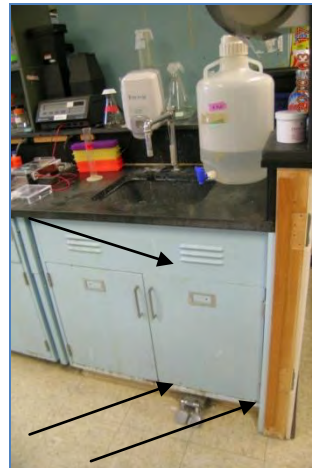
The photo at left shows a typical laboratory in Bldg 23, with the original fume hood in place. Shown at right is the condition of casework, typical throughout the space. Note the corrosion.

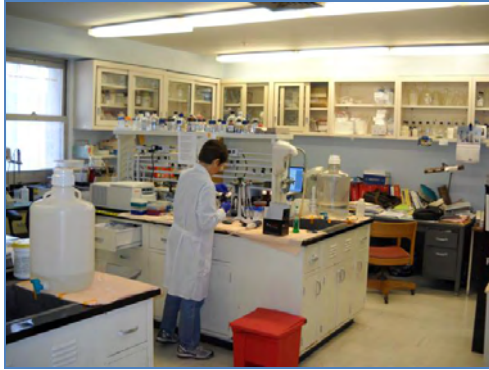
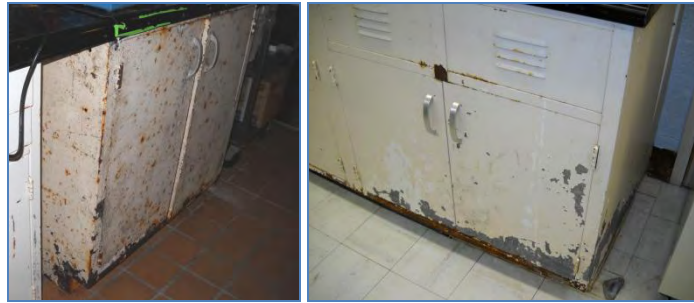
The photo at left shows a typical laboratory in Bldg 1. Some casework has been painted to extend its life, but generally casework is older and in need of replacement. Some laboratory spaces have severely corroded casework as shown in the next two photos.

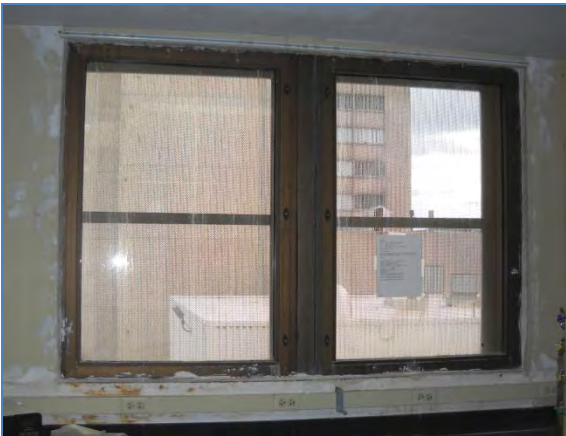
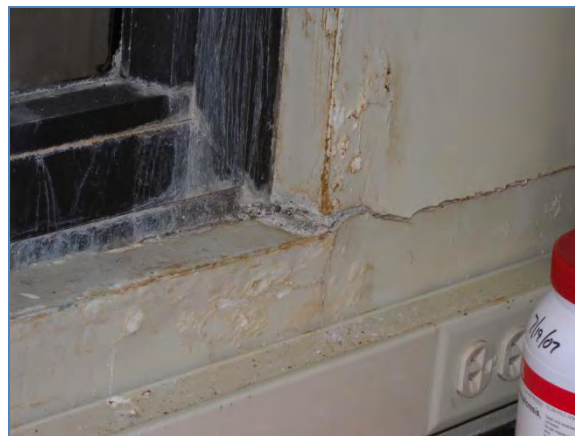
In Building 7, there is extensive leakage around the exterior windows that has caused significant damage to interior finishes.

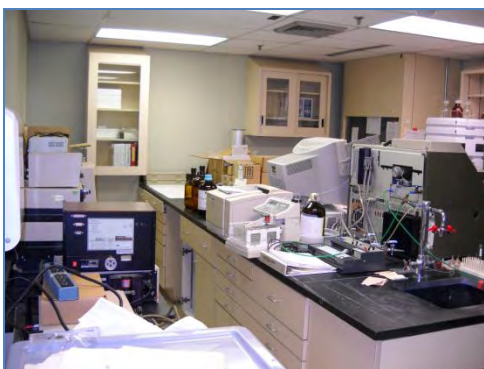
Crowded laboratory conditions.

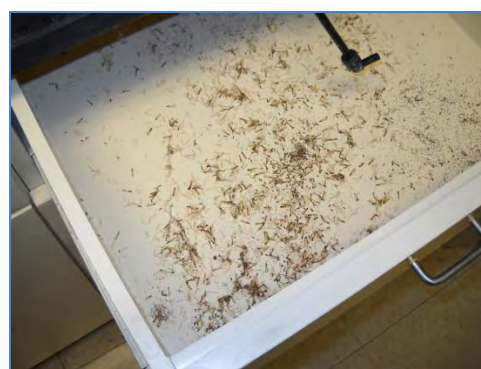
Dead insects in the drawer of a base cabinet.

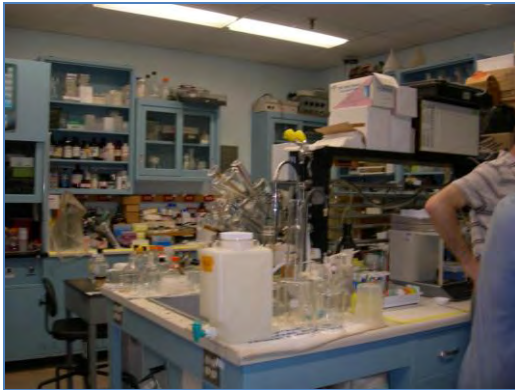
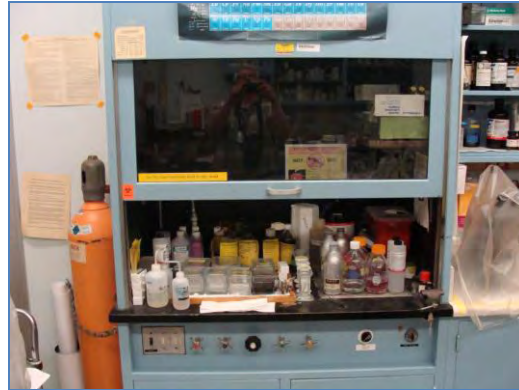
Some of the laboratories in Building 1 are very crowded. In this one, the fume hood is being used for storage.
