Final Report of the VA Research Infrastructure Program

Veterans Health Administration
Office of Research and Development
July 2012

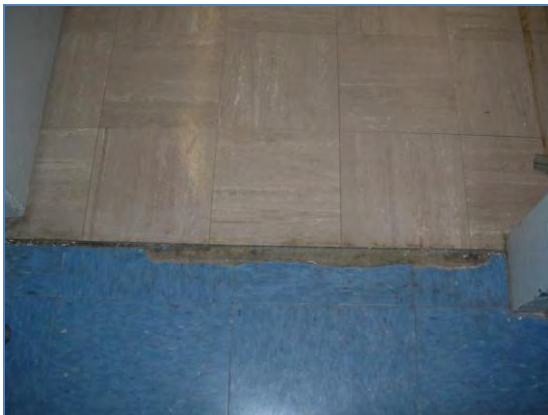
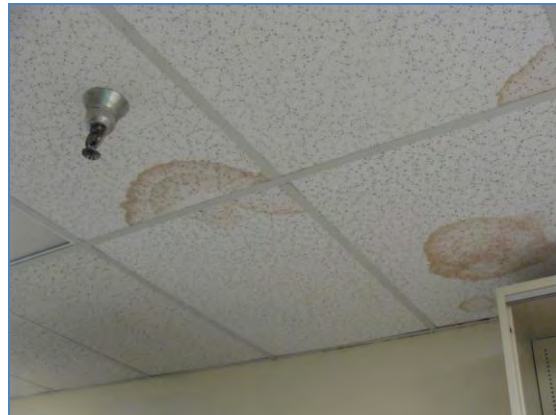
Some laboratories have evidence of damage within such as this damaged floor at a laboratory entrance (left photo) and the stained ceiling tiles caused by leakage (right photo).

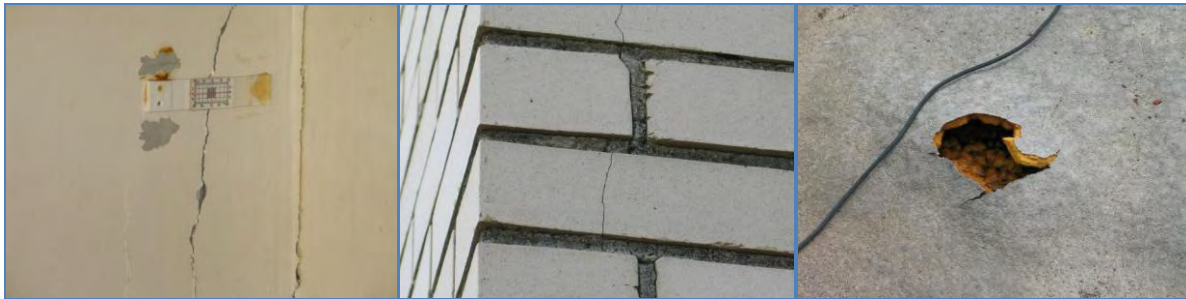
Examples of (left to right): interior cracking, exterior cracking, roof deterioration.

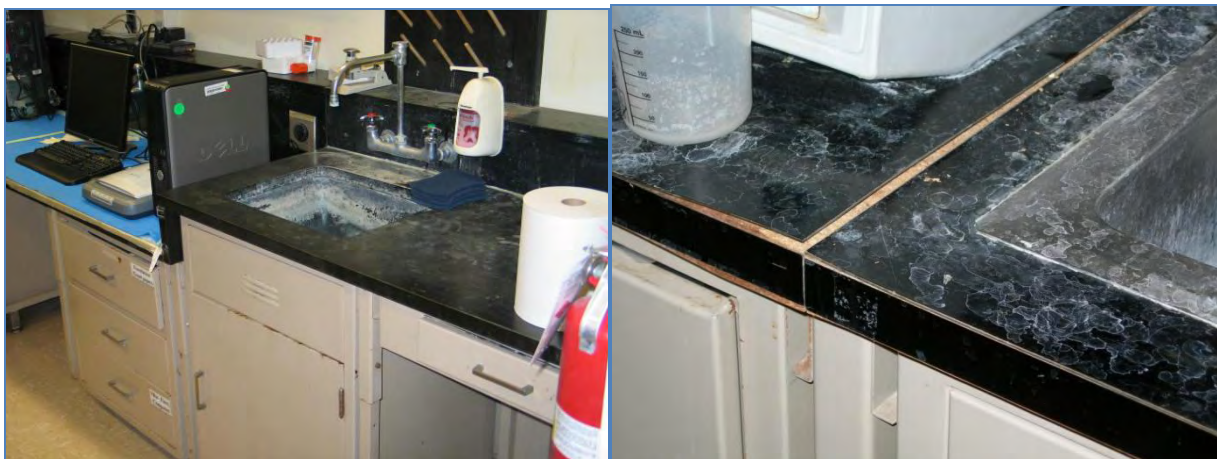
The photo at left depicts typical condition of casework in the laboratories. The photo at right show what can happen when an inappropriate finish (plastic laminate countertop) is used in a laboratory environment.

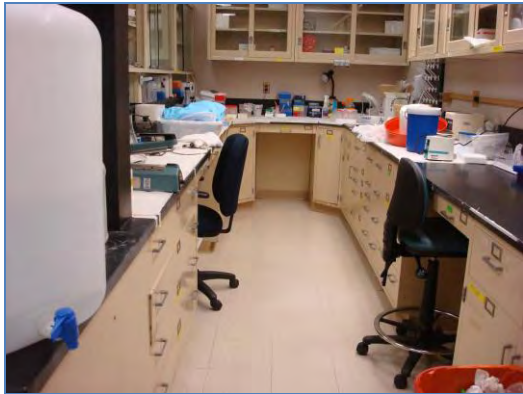
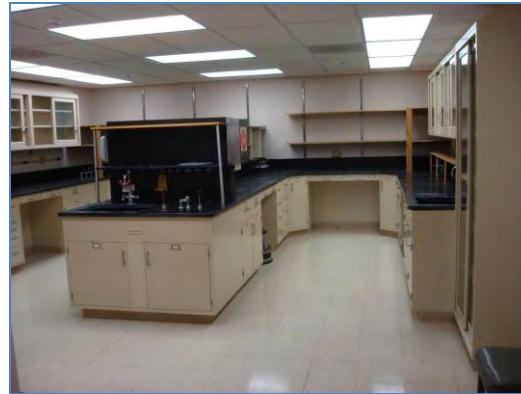
(Left photo): Some laboratories have very tight spacing between benches. (Right photo): A wider view of a laboratory unoccupied at the time of the assessment.

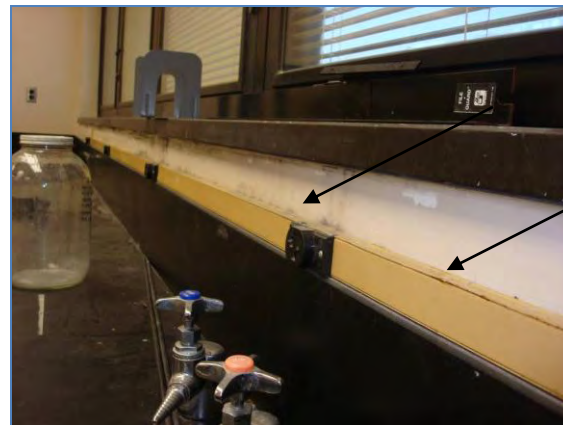
Evidence of leakage beneath a window (rusted electrical raceway, mold growth).

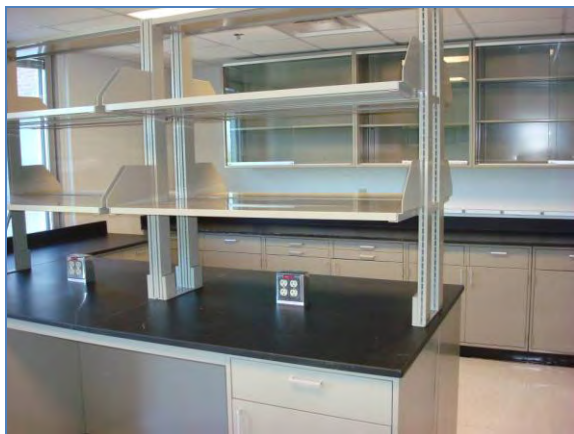
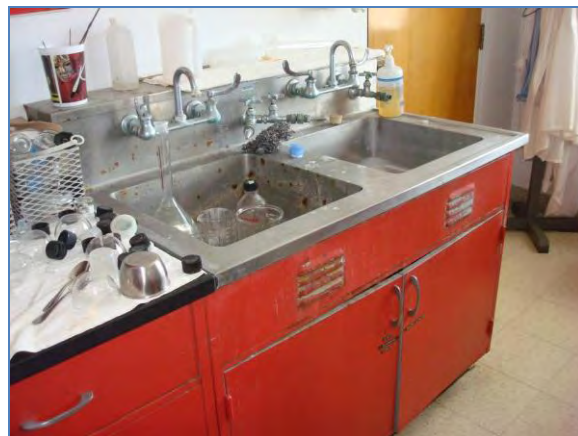
The photos above show the significant difference between a renovated laboratory (at left) and a non-renovated laboratory (right photo) in Building 1.

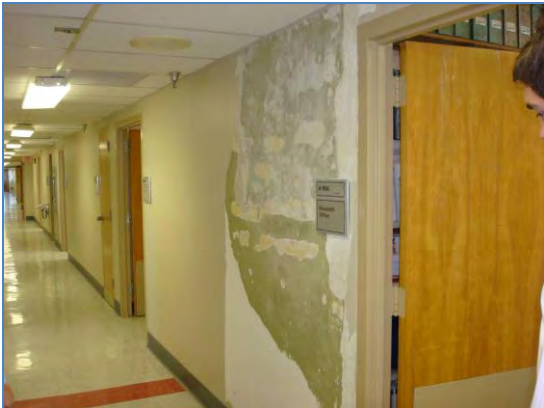
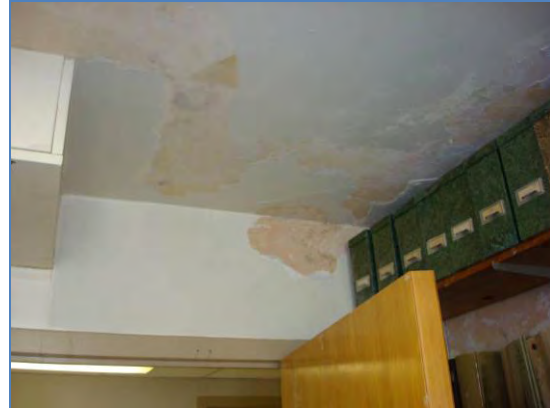
Roof leaks have resulted in some water damage in Building 1. Both photos above show damage that has partially been repaired.

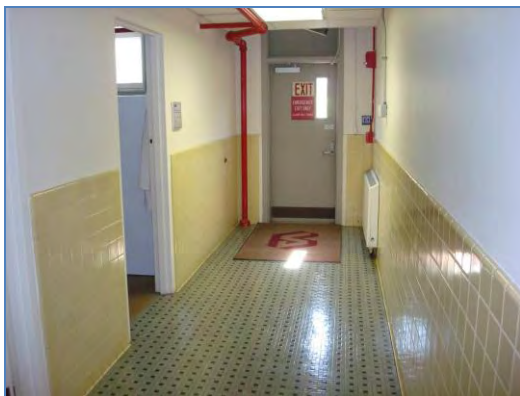
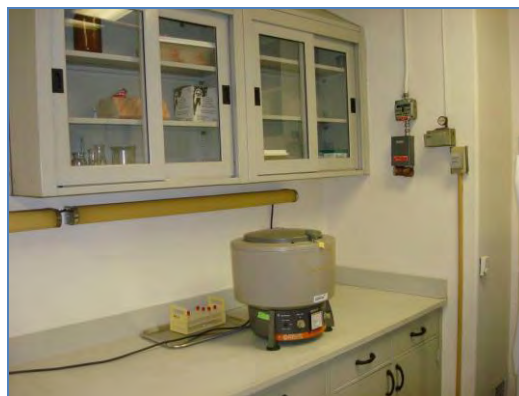
Building 12 which houses the VMU is in the best condition of all research space on the campus. Shown above at left is the interior view of the VMU's main entrance. The right photo shows a procedural laboratory.

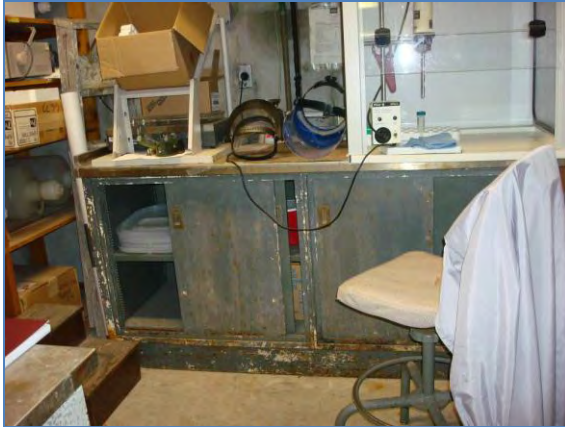
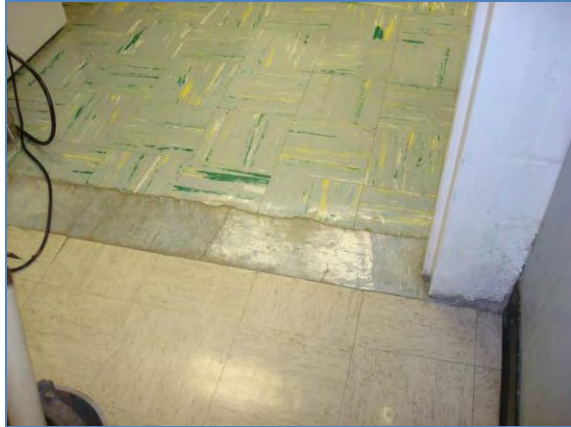
By contrast, Building 19 is in poor condition and not suitable to house research laboratories. The photo at left shows what is likely the worst laboratory in Building 19. The photo at right shows vinyl asbestos tile flooring in Building 19.

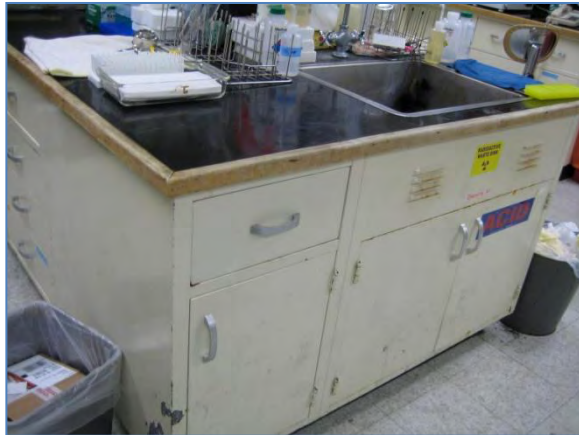
The photos above and below show Building 1 laboratory space in disrepair and in need of significant renovation.

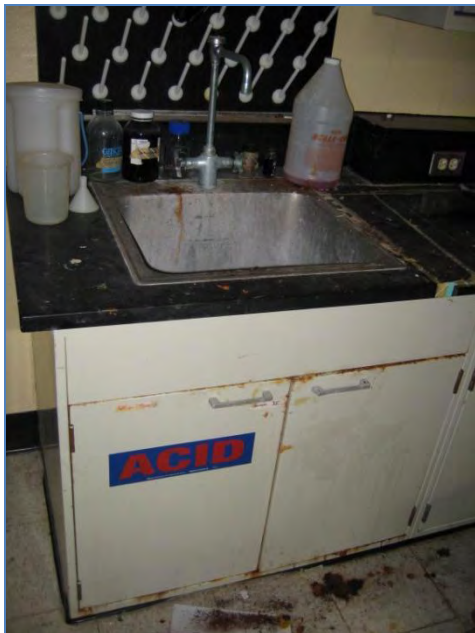
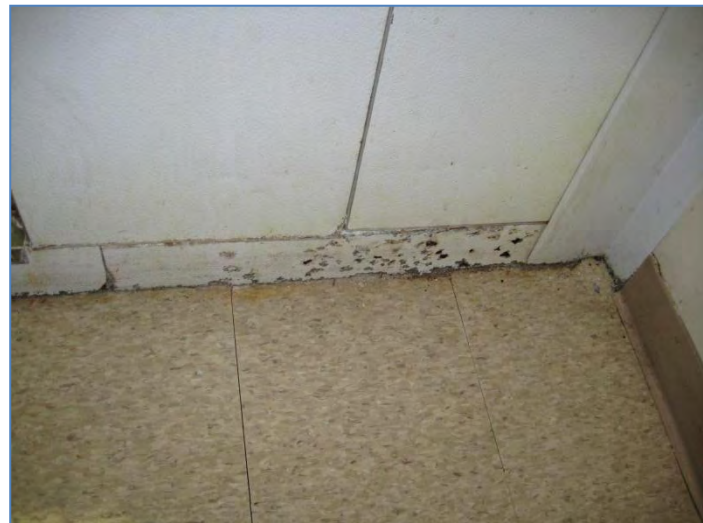
Research space in Building 7 has fared much better. Dating to the late 1980s, it has obviously been well maintained and most of the aging casework is in good condition. There is a lack of adequate storage, so the laboratories are very crowded. Major equipment is in good working condition. The mechanical systems are aging, but have been well maintained. There is a lack of emergency power for the laboratories, although the emergency generator is in good condition and has adequate capacity. There also is a lack of central monitoring of freezers and other equipment.

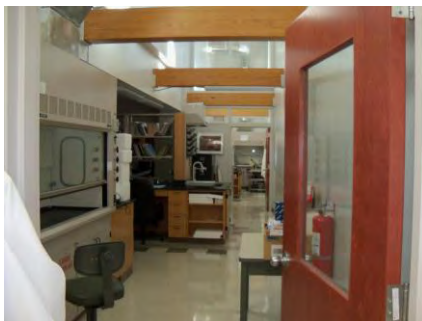
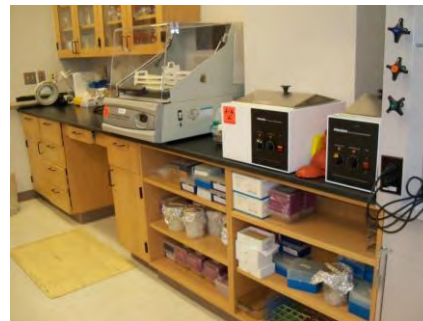
(Left photo): The overall laboratory design incorporates a light well that links the mechanical space to the laboratories, accommodating utilities and ductwork well while allowing natural light into the spaces. (Right photo): General view of laboratory casework.

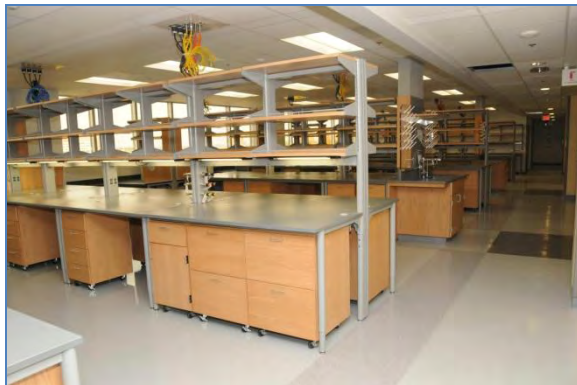
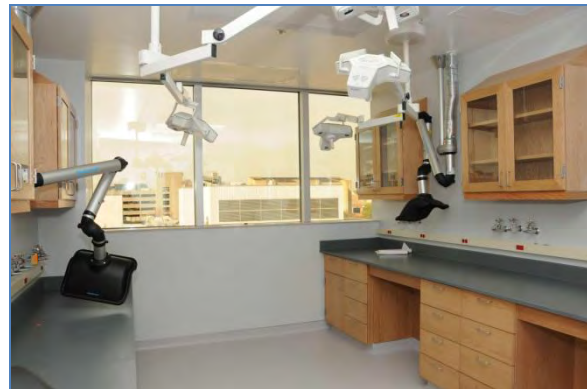
The VMU is well maintained. Currently there is ample capacity for mice and rats. However, if the animals currently housed at the affiliate were required to be moved to the VAMC, there would not be adequate capacity. The VMU experienced the failure of an air handler in August 2007. Research management, VMU staff, and engineering responded appropriately and prevented the loss of any animals, but ongoing experiments were interrupted causing investigators to lose valuable results. Currently there is a project in design phase to replace the two air handling units that serve the VMU.

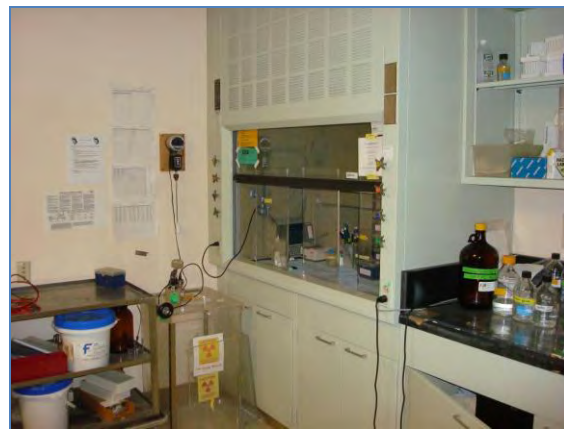
Laboratories in Building 1 were retrofitted into former clinical space. There are insufficient clearances between benches (left photo above) and general overcrowding due to lack of sufficient storage space.

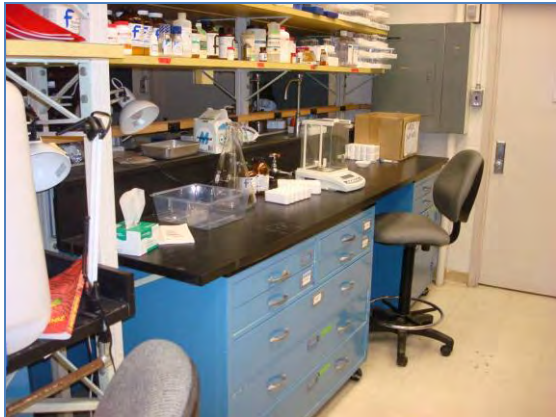
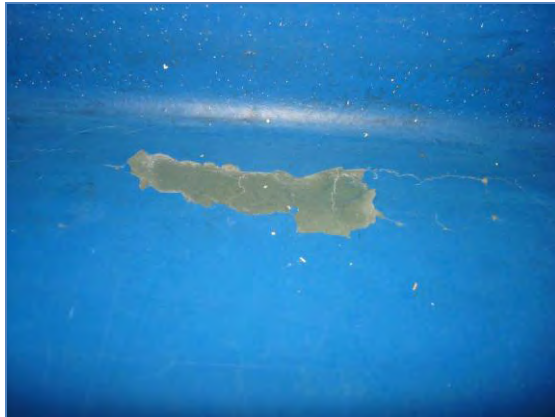
The laboratories in Building 15 are in need of renovation. The photo at left shows typical laboratory casework with inappropriate plastic laminate countertops. At right, the epoxy flooring in the VMU was deteriorating in spite of being recently updated. The contractor who performed the work was correcting the problem areas.

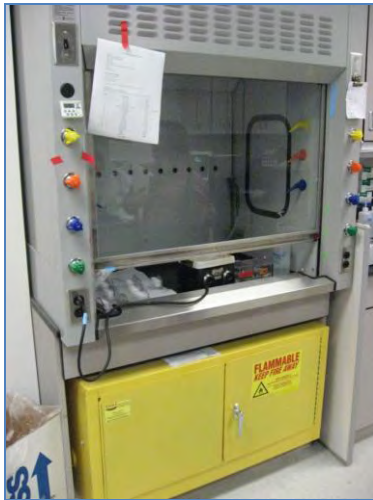
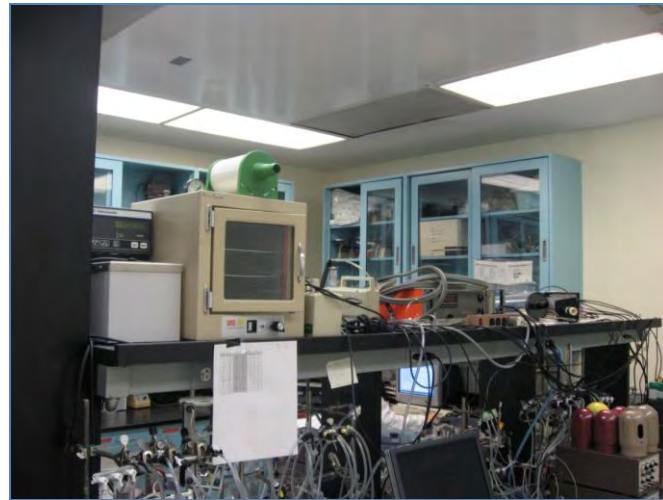
(Left photo): This new fume hood (in a renovated laboratory) has a removable flammable storage cabinet. The hood converts to an accessible hood. (Right photo): One of two laboratory spaces that has not been renovated.

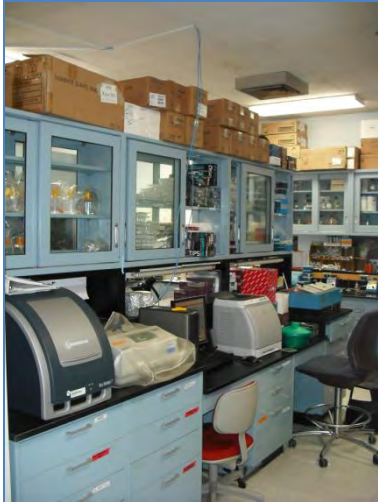
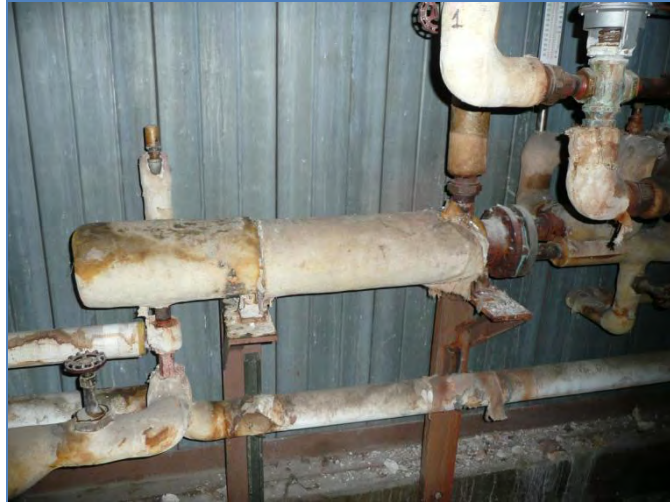
The space in Buildings 22 and 31 are dramatically different. The photos above of Building 22 are indicative of the space and the systems having had little or no updates in the past 40 years. (Left: a typical Bldg 22 laboratory; right: the heating hot water heat exchanger that is original to the building.)

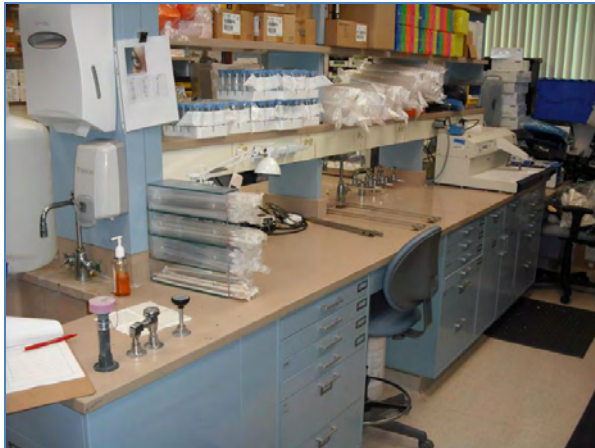
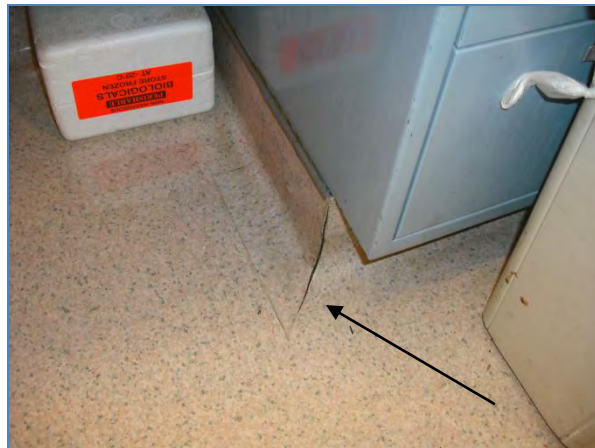
Building 31 was constructed in 1995. It is a three level building (two floors above ground, plus a basement) that houses laboratories on the top two floors and the VMU on the basement level. Building 31 has very well designed laboratories and support spaces, and laboratory finishes and casework are in good condition. The one exception is a problem with the flooring at the base of casework where the seamless vinyl is cracking.

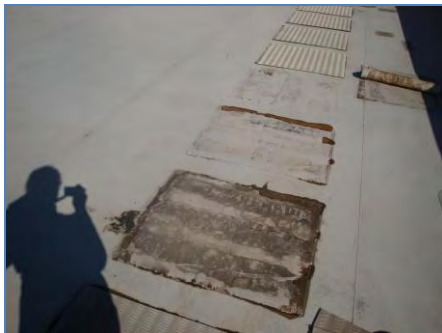
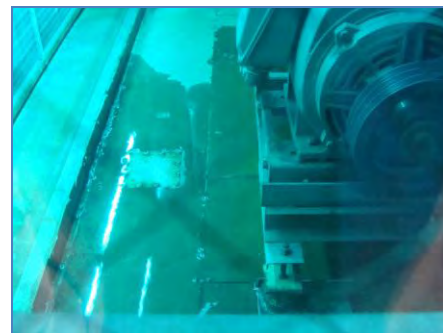
Building 100 is at the age where significant problems will begin to show. (Left: The roof is not leaking yet, but it is beginning to deteriorate. Center: Evidence of leakage and corrosion at an air handling unit. Right: Standing water in an air handling unit.)

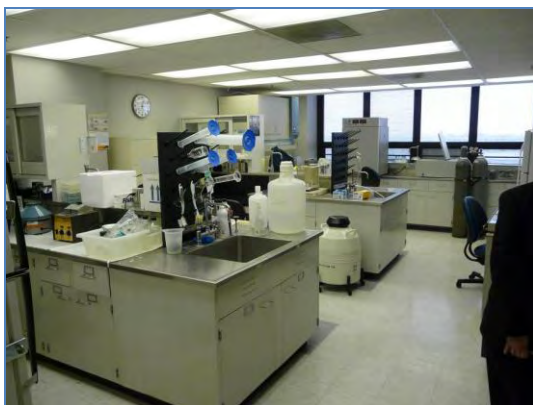
A typical 3-bay laboratory in Bldg 11A.

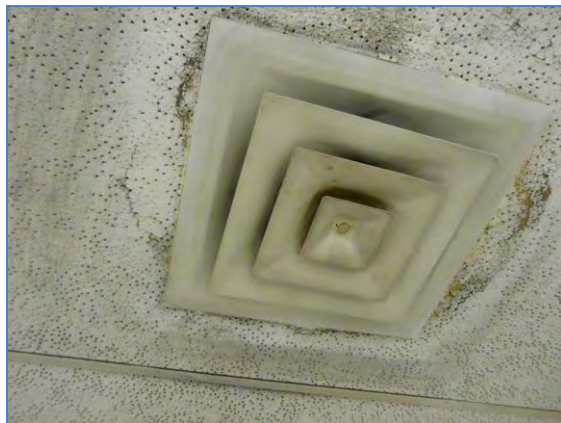
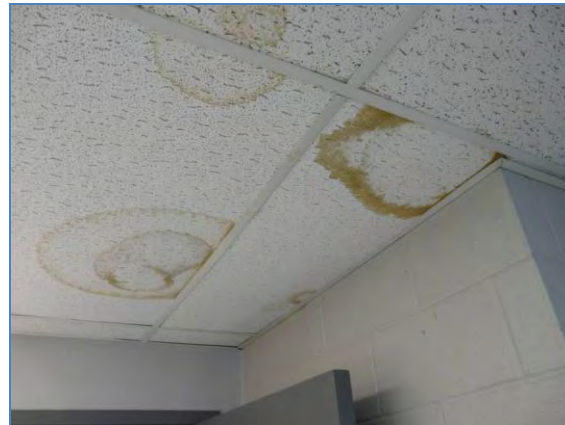
More views of Building 11A – at left, a dirty HVAC diffuser and ceiling tiles. At right, the ceiling shows evidence of leaks.

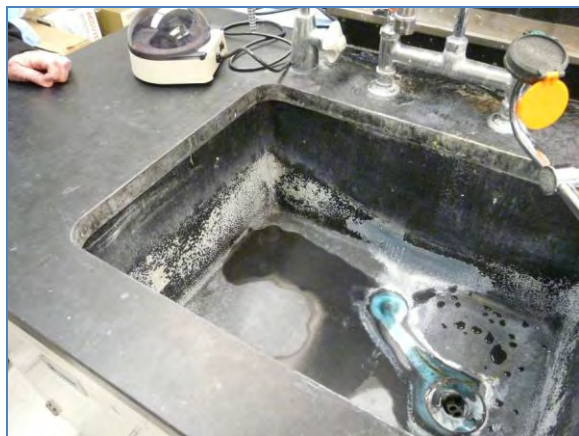
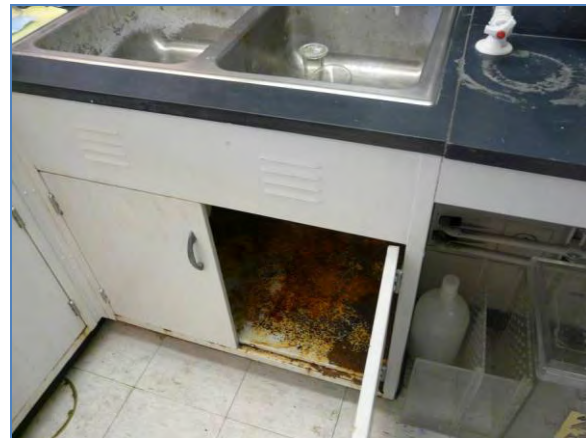
There is no central backflow prevention to separate laboratory water from potable water within the building. Mechanical systems are in fair condition. The exhaust system does not have the appropriate vertical stacks for discharging from the building and should be corrected. Electrical systems (normal and emergency) are in fair condition.

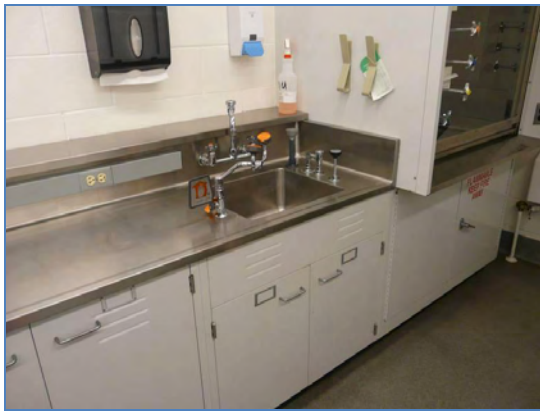
A procedure room in the VMU.

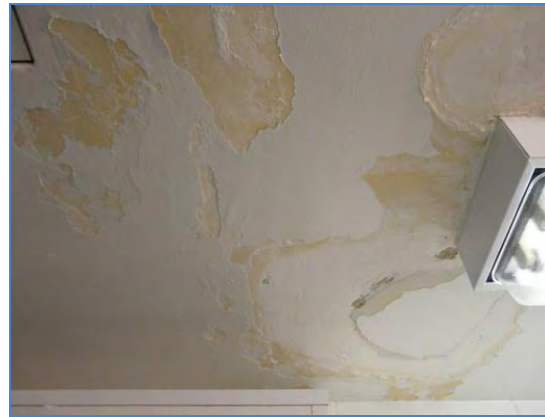
**Evidence of leakage in the VMU.
A significant leak in May 2010
necessitated evacuation of animals.**

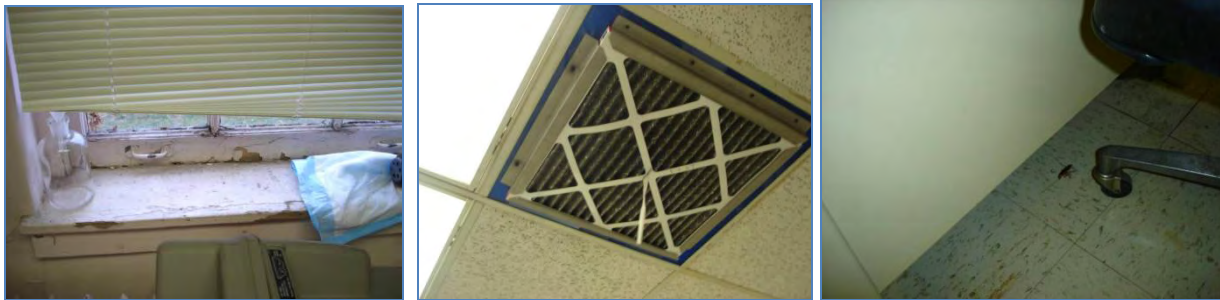
Examples of the poor conditions in Building 1 include (above, left to right): Some original exterior windows remain on the building; a laboratory user's solution to friable insulation dust coming from diffusers; and a dead roach in a laboratory.

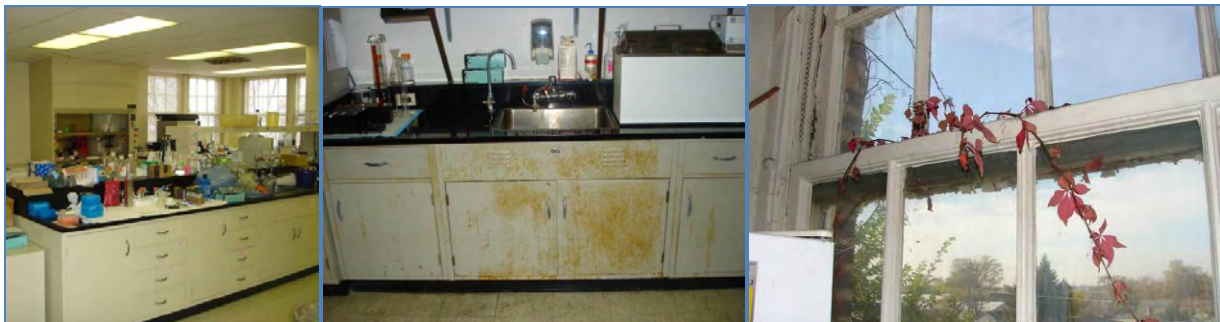
Most of Building 1 is not covered by a fire sprinkler system. Building 229 has no sprinkler system. Building 1 at North Chicago has no sprinkler system.

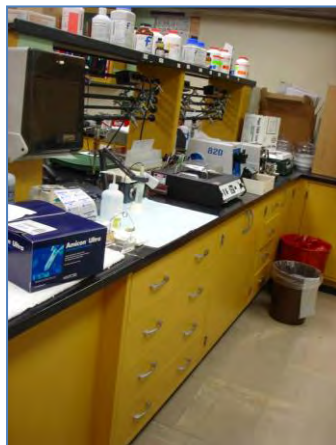
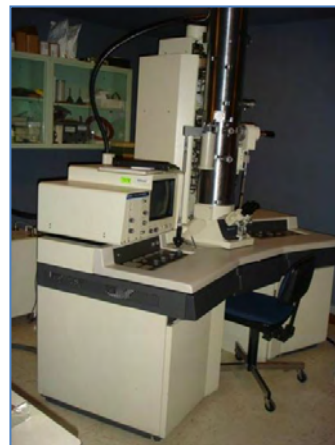
Two views of A wing: laboratory casework and electron microscope.

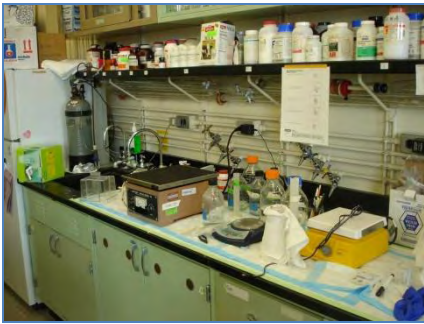
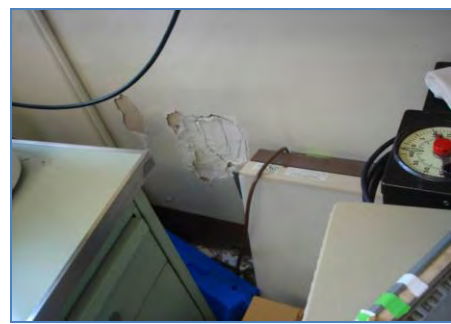
C Wing laboratories are in the worst condition. Shown above are (left to right): typical C Wing laboratory casework; damaged sink in a C Wing laboratory; and wall damage.

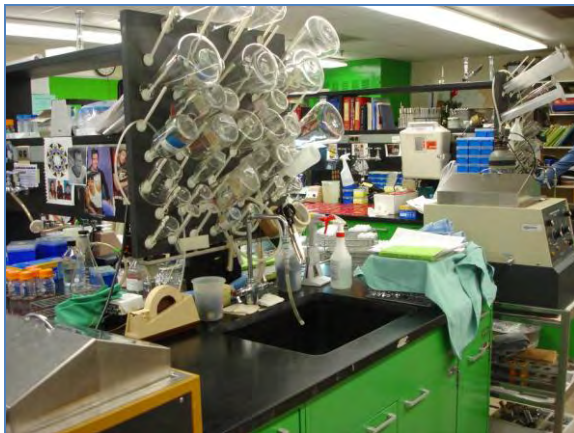
A typical D Wing laboratory.

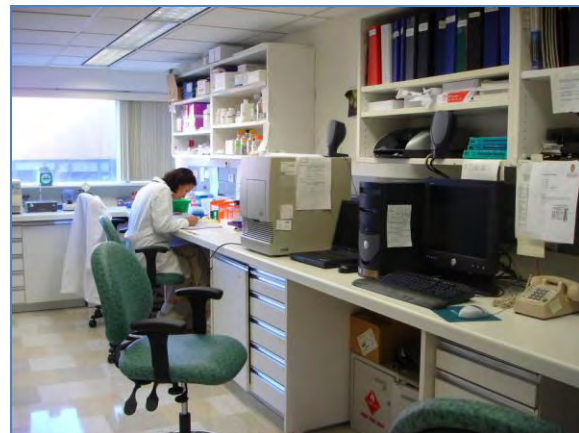
The GRECC laboratories, also on D Wing, are the best laboratories at the Madison VAMC.

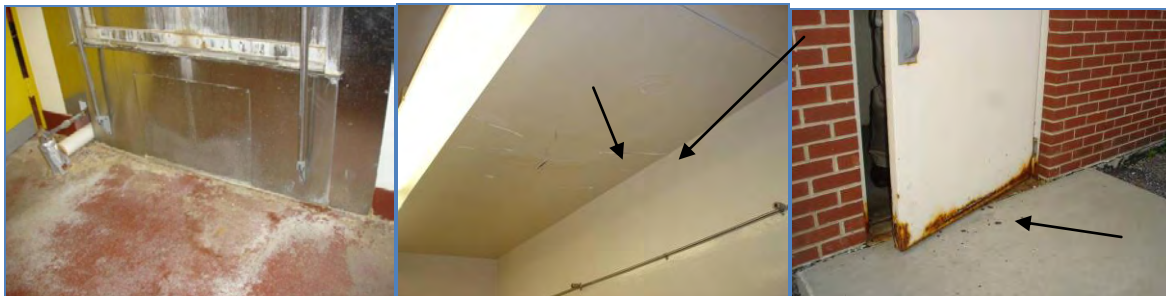
Damaged finishes in the VMU include (left to right) flooring in front of the cage washer, ceilings, and an exterior door.

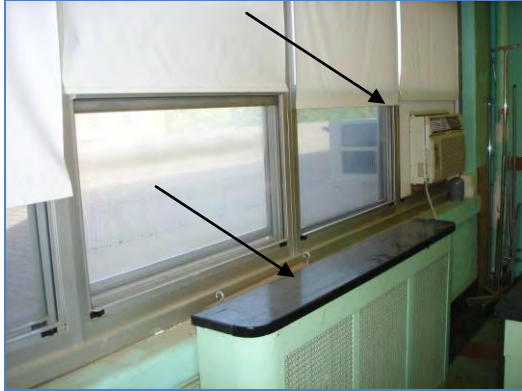
Typical heating and cooling units in laboratories.

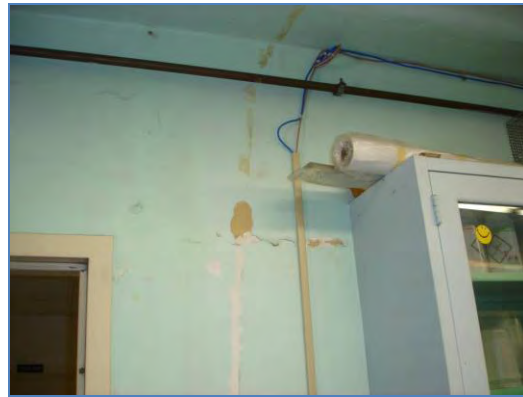
Evidence of water damage is prevalent.

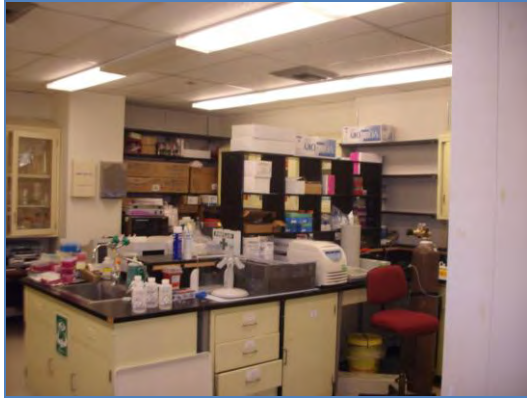
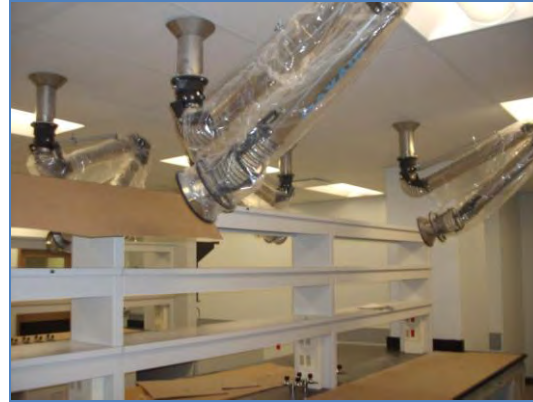
With the exception of A Wing, laboratory space has been renovated. The photo at left shows an A wing laboratory. The photo at right shows a recently completed but not yet occupied laboratory on F Wing.

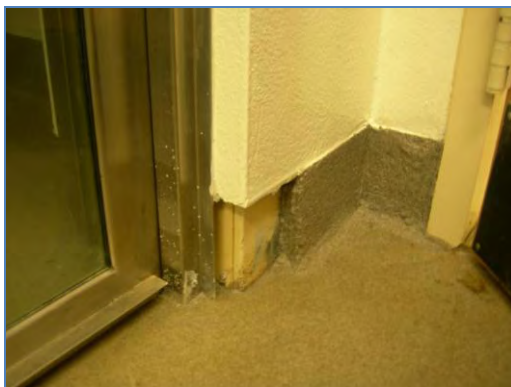
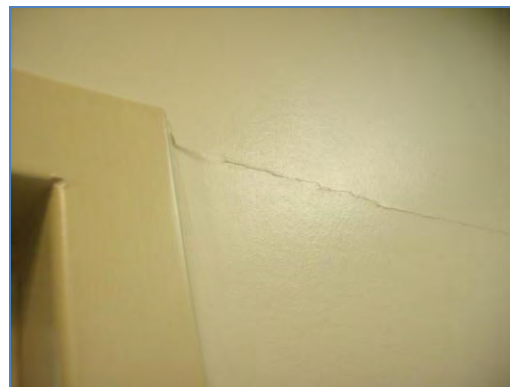
There are a few damaged finishes in the space. The photo at left shows damage to a wall base in the VMU. At right, the drywall around a door frame is cracked.

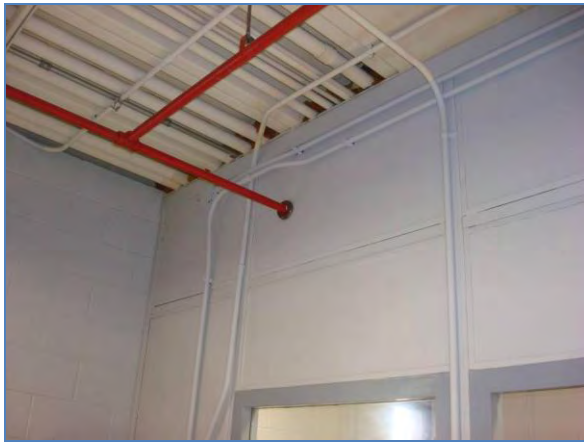
In Building 15, a laboratory with no ceiling and a wall of temporary panels.

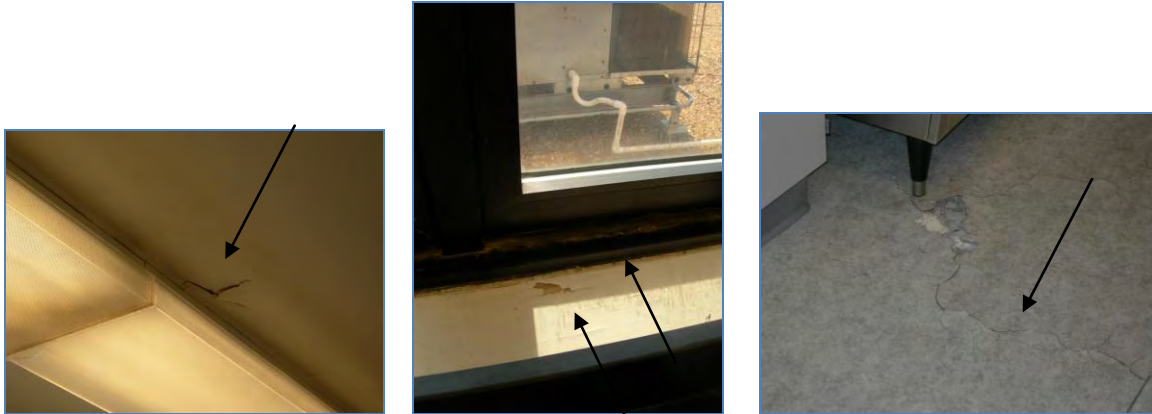
The photos above show damaged finishes in Building 1 research space.

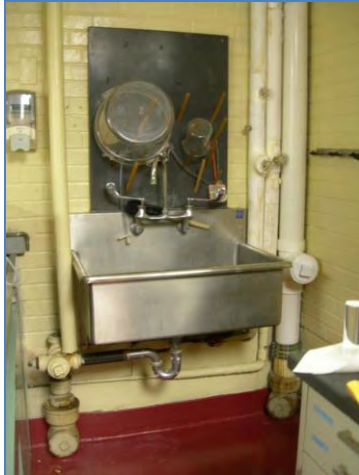
Rusted exposed piping in an animal use area.

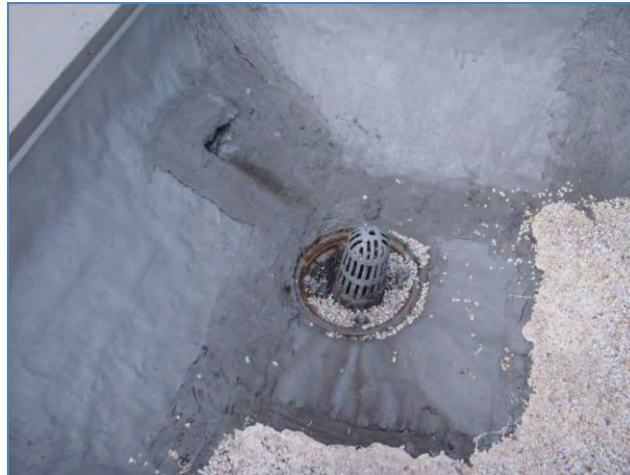
Damaged roof membrane, Bldg 6.

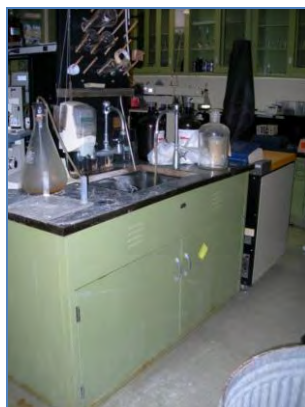
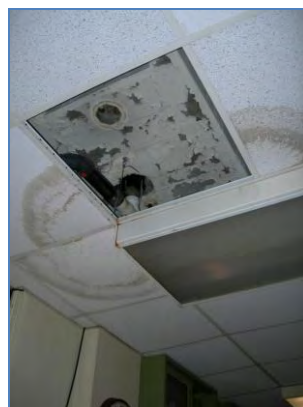
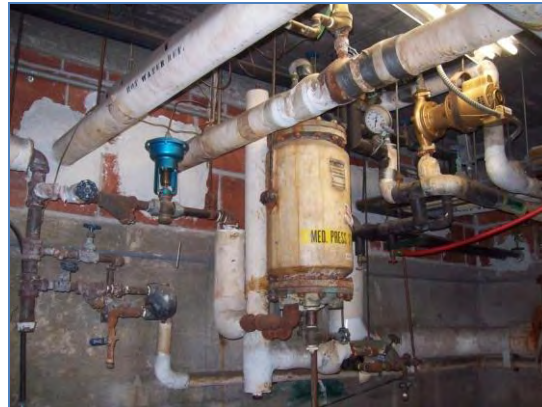
Views of Building 7: (left to right) a typical laboratory, a water damaged ceiling, and an aging heat exchanger.

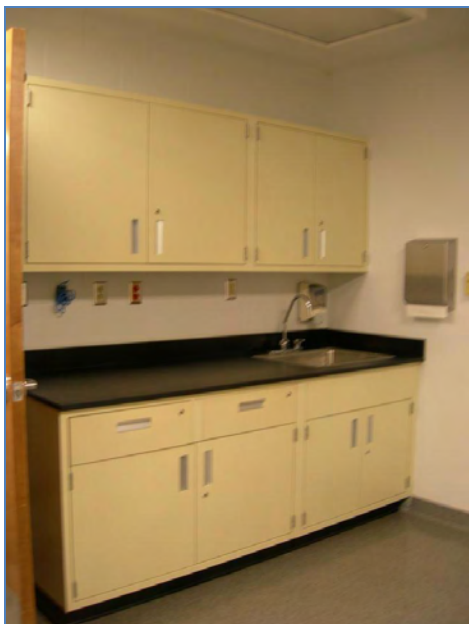
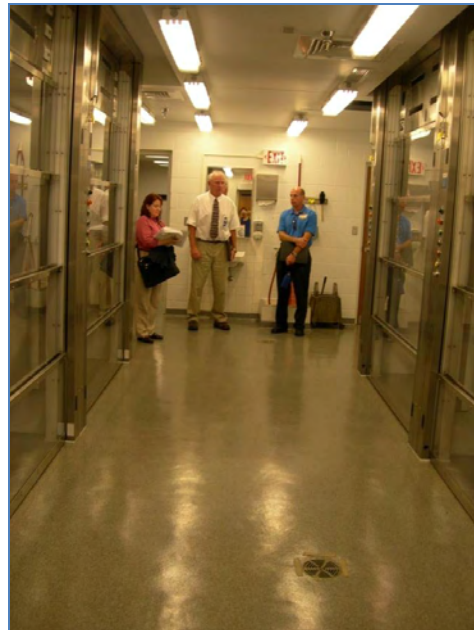
Two views of Building 1, Jefferson Barracks Division. At left, casework in a newly renovated laboratory. At right, the VMU has been nicely renovated.

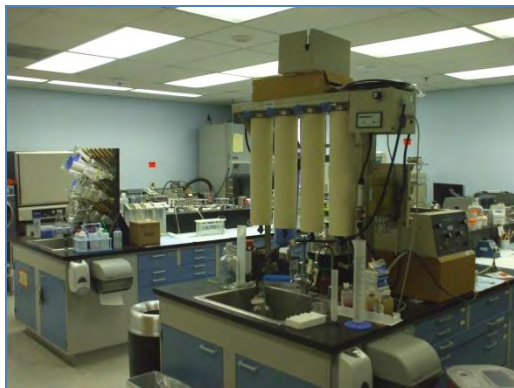
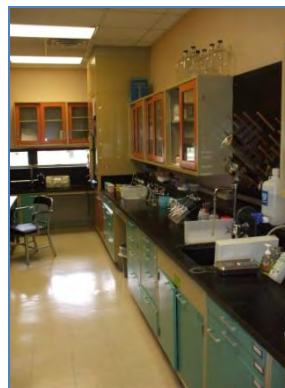
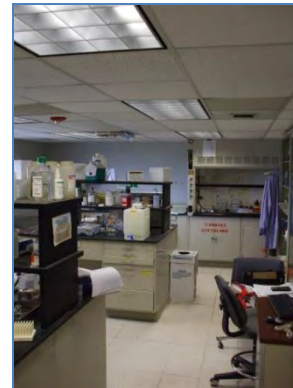
Examples of typical laboratories in all three buildings on the Houston VA campus: from left to right, Building 100, Building 109, and Building 110.

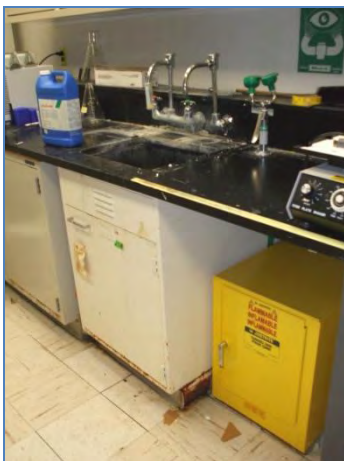
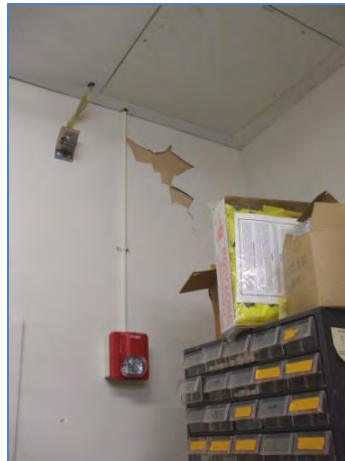
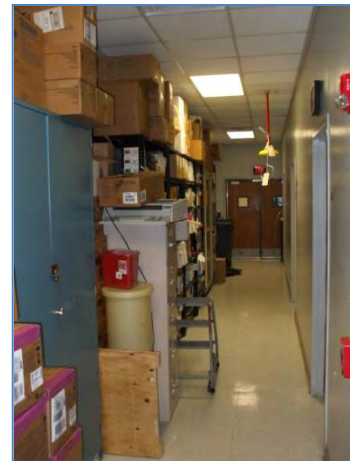
The photos above are examples of corroded casework (left), damaged finishes (center), and crowded conditions (right) in Building 109.

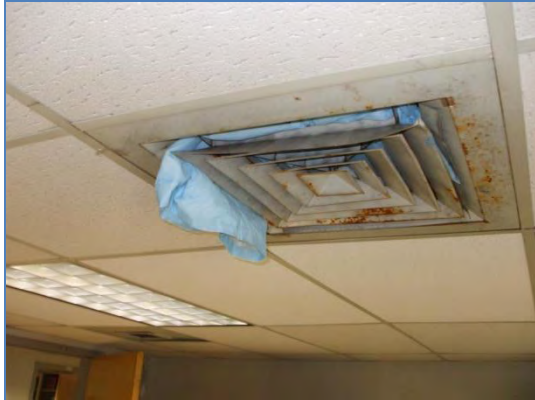
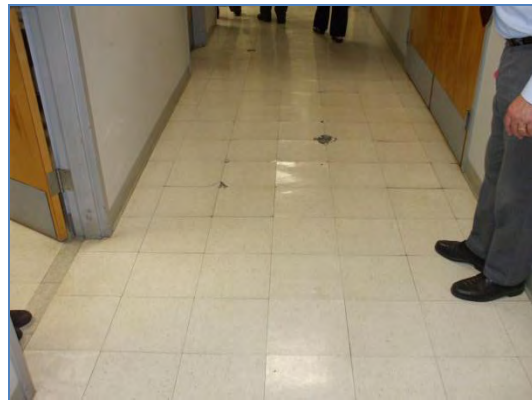
The laboratories in Building 110 are in the worst condition. The photo at left shows a dirty and corroded air diffuser. At right, the tile flooring in the corridor is damaged.

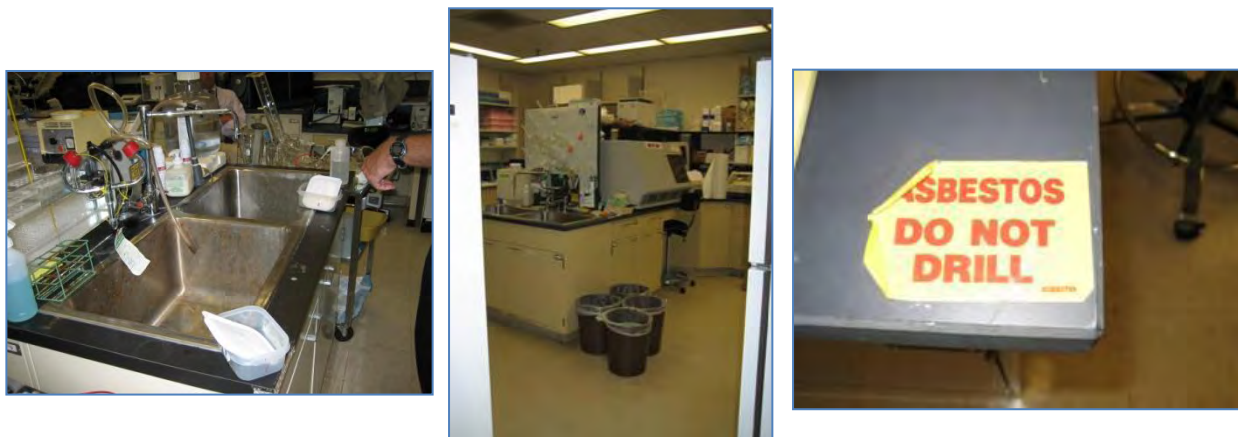
Examples of typical laboratory conditions at the Little Rock VAMC.

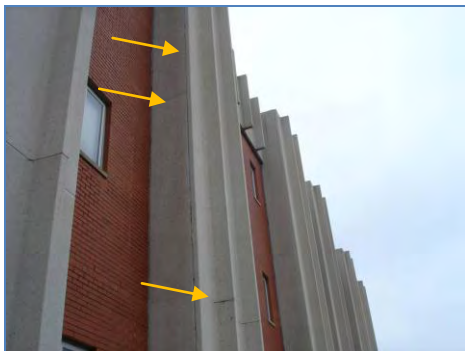
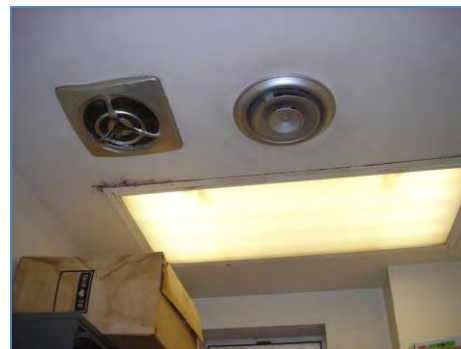
Interior spaces of Building 19 show evidence of water damage caused by the exterior seals between pre-cast panels (mechanical vertical shaft) either missing or deteriorated (left photo). At right, a deteriorated laboratory ceiling.

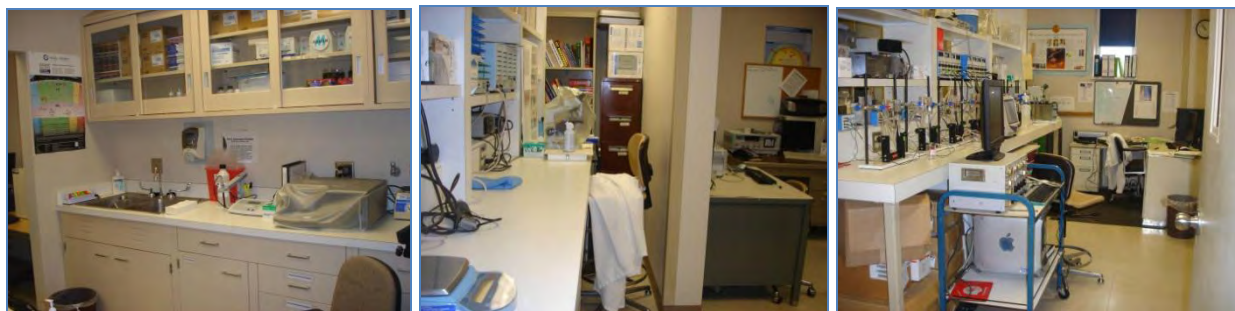
Typical laboratory views. Note the shallow countertops (24 inches rather than the standard of 30) at left, and tight working conditions on other two photos.

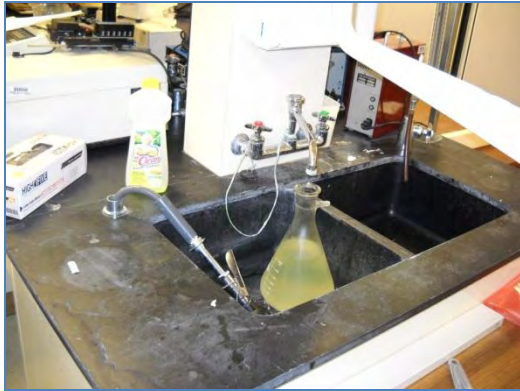
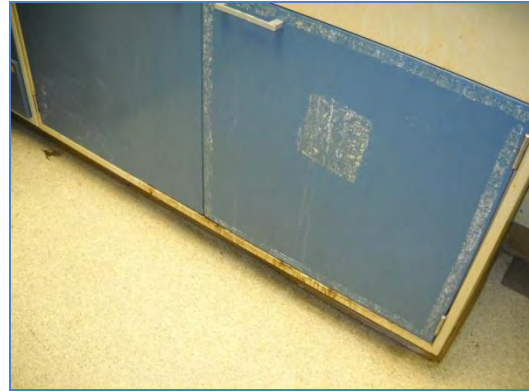
Photos above show conditions in Building 3 laboratories: at left, a corroded and stained countertop and, at right, corrosion on laboratory casework.

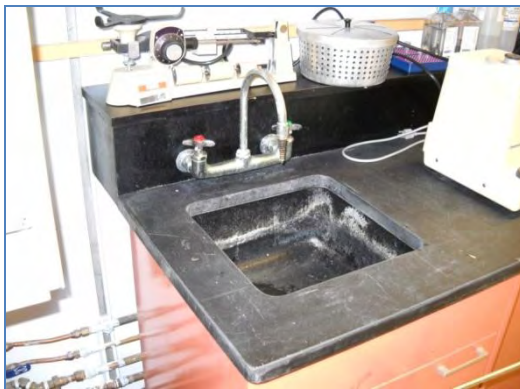
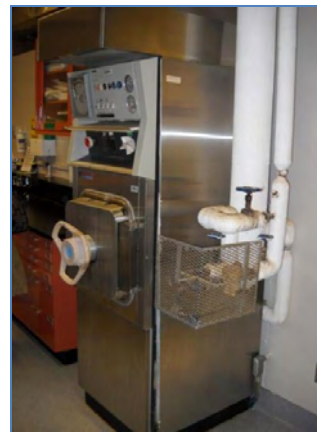
The electrical system is also aging, and there is not ample capacity in the emergency power system to fully support the building. Ground fault protected receptacles are not consistently placed throughout the space where they should be, i.e., near sinks. There also is no transient voltage surge suppression to protect sensitive electronics. There is no emergency lighting in the laboratory areas.

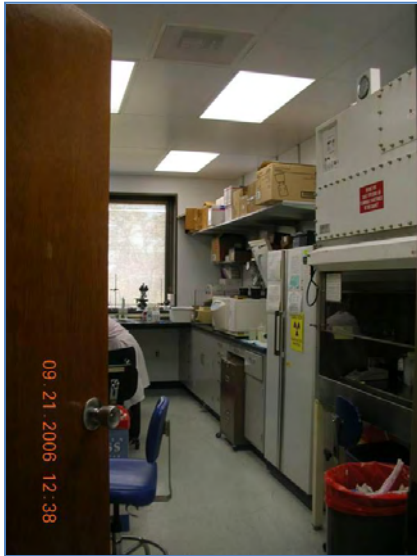
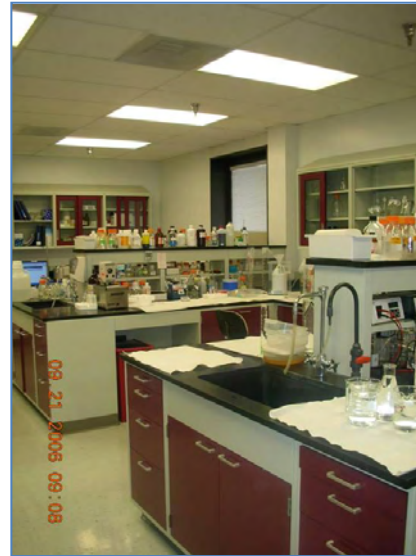
The photos above and below are indicative of research space at the Audie L. Murphy Memorial Veterans Hospital.

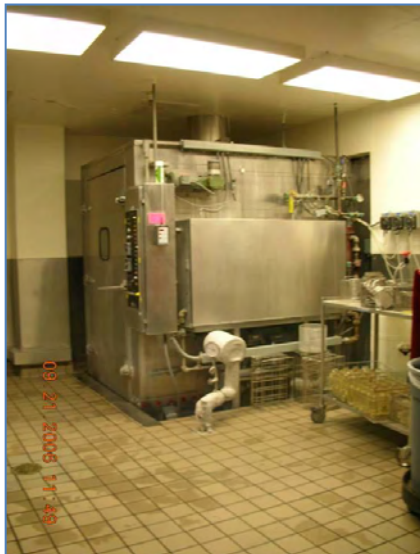
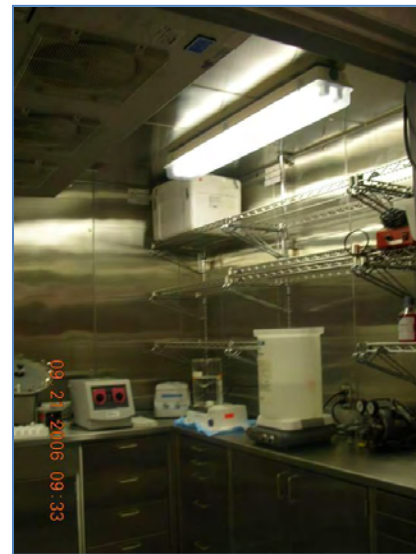
Veterinary Medical Unit (VMU): The VMU is located on the second floor adjacent to laboratories. Access is controlled by a card reader. It is a well maintained and clean facility with one of the highest animal census in the VA system. One problem noted, however, is that there is a very strong odor noticeable upon entry in an area where caging has not been transitioned to ventilated caging systems. Use of ventilated systems in other areas of the facility make a noticeable difference.

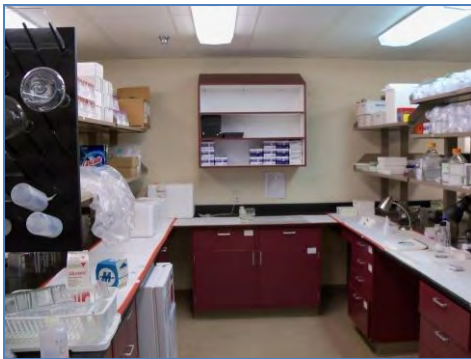
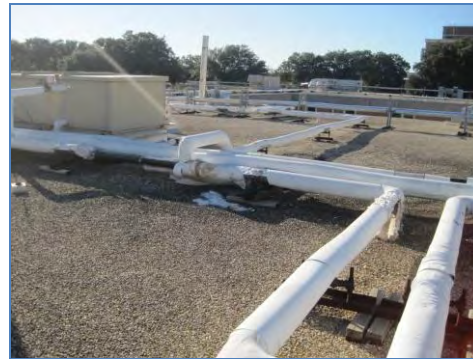
At left above, laboratory casework is generally in good condition but interior finishes are damaged due to water leakage. At right, deteriorated piping and insulation at a rooftop air handling unit.
