Final Report of the VA Research Infrastructure Program

Veterans Health Administration
Office of Research and Development
July 2012

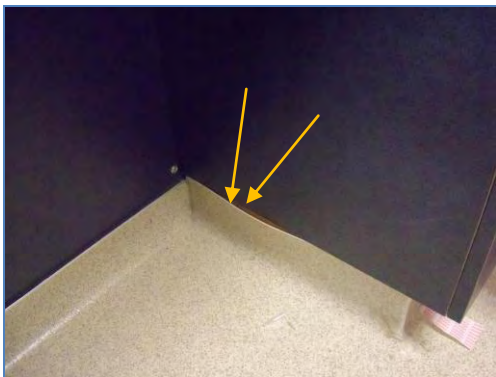
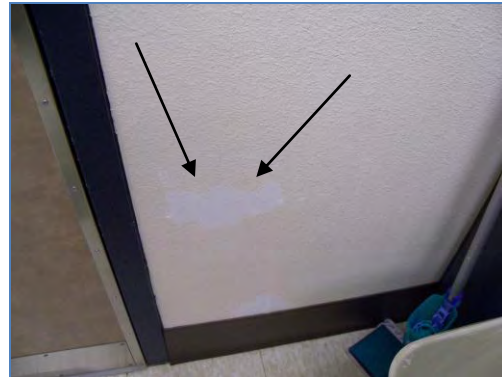
The third floor laboratories in Building 205 have some deficient finishes. At left, the sheet vinyl flooring is pulling away from the base of casework. The photo at right shows stippled paint in a tissue culture space that is chipping off.

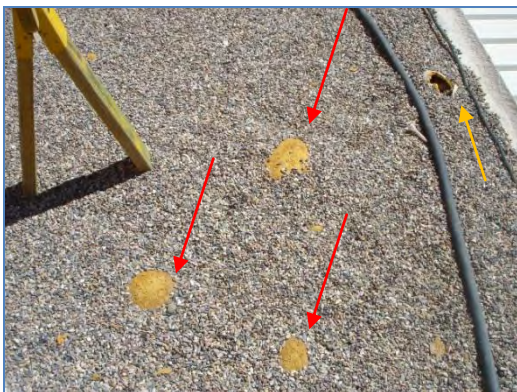
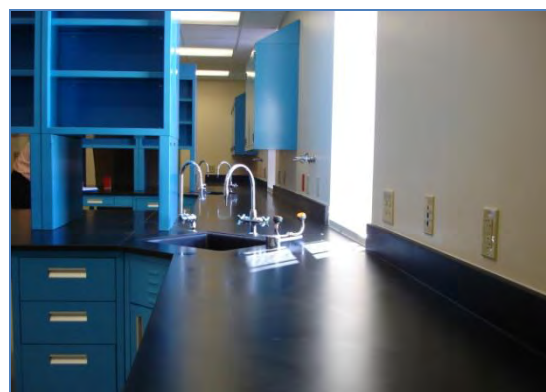
The roof of Building 10 was not replaced when the laboratory space was renovated. A roof replacement project is current in contracting. The photo at left shows bubbled roof layer (red arrows) and broken roof layer (yellow arrow). At right is a newly renovated laboratory.

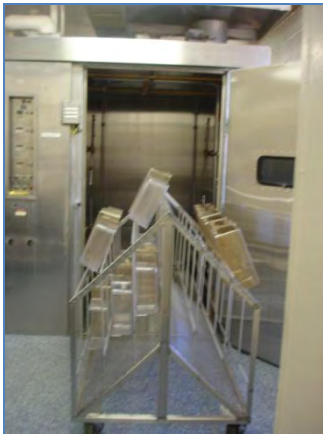
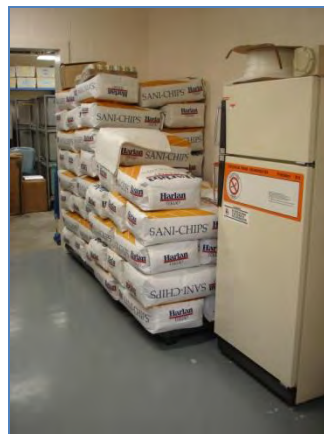
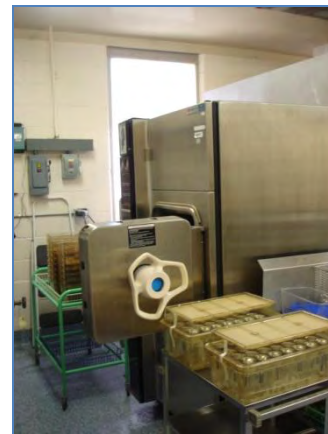
The VMU in Building 10 (pictured above) will be renovated beginning in FY 2012.

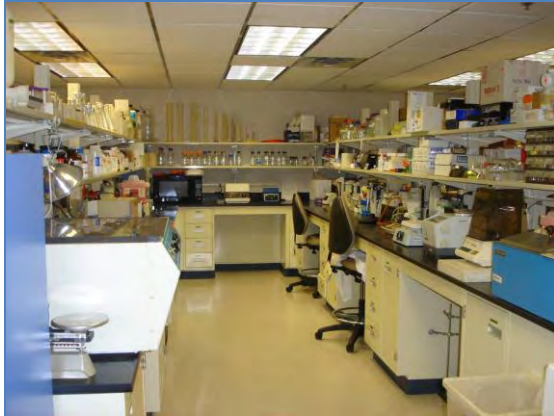
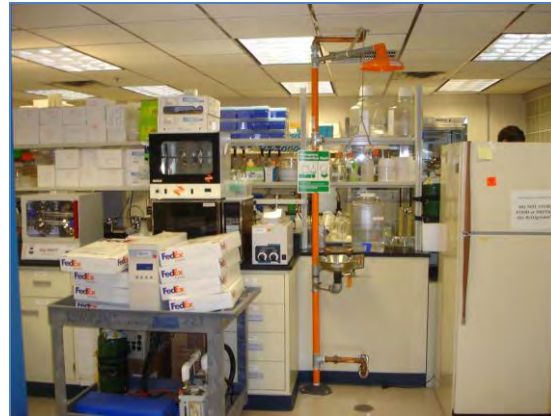
The photos above show typical laboratory conditions in Building 21. The photo at right also shows a safety shower and emergency eyewash that meet current requirements.

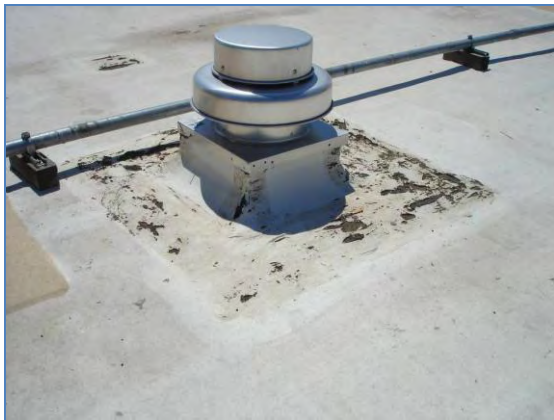
The photo above shows the deteriorated condition of the Building 21 roof at the time of the assessment. The roof has since been repaired.

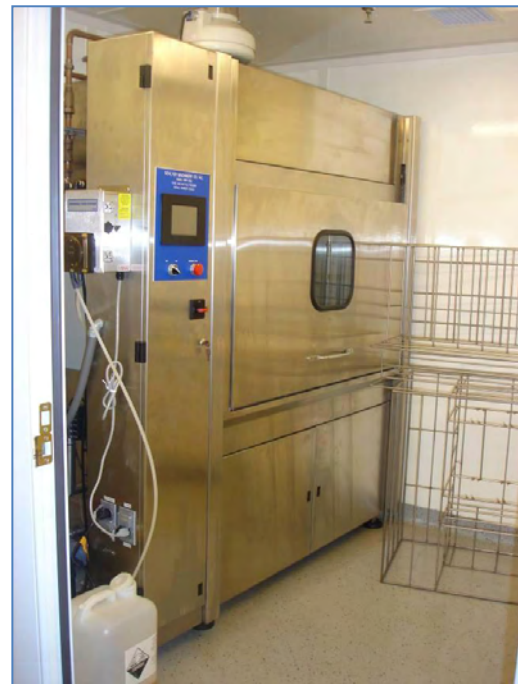
Problems with the space include leaks from the roof during and following rain, temperature and humidity irregularities, and lack of emergency power for mechanical systems. On the roof, there is significant cracking around the rooftop mechanical equipment. An area of the roof at least as large as the laboratories should be patched to correct the problem.

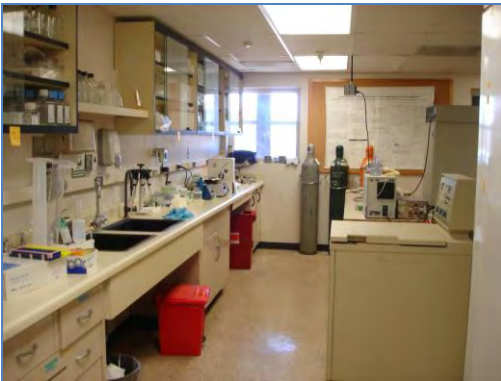
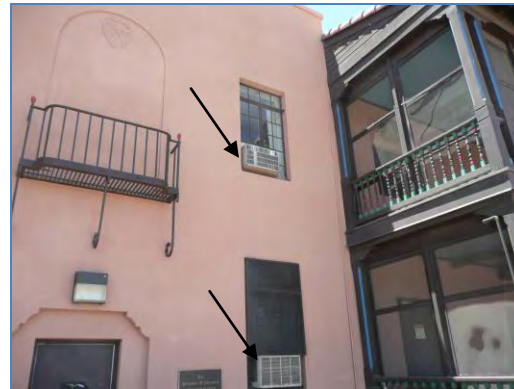
Above left, a typical laboratory in Building 6. At right, this view of the exterior shows the window air conditioning units.

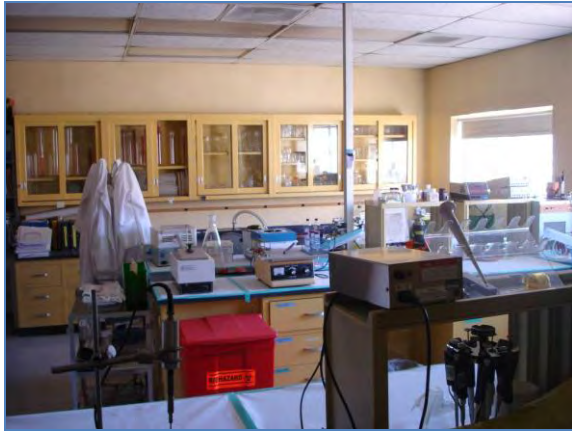
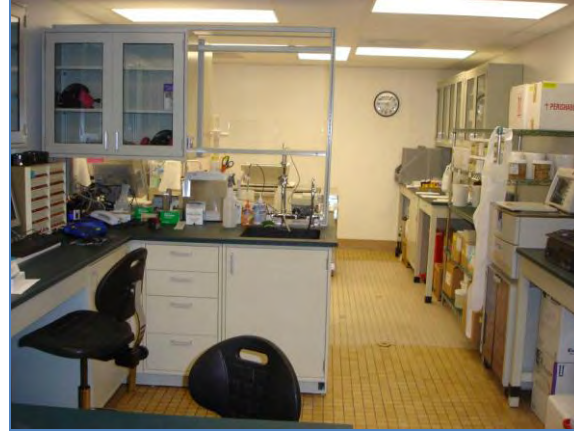
The photo at left shows a typical Building 10 laboratory. At right, the few laboratory spaces in Building 38 are expected to be lost for medical records storage.

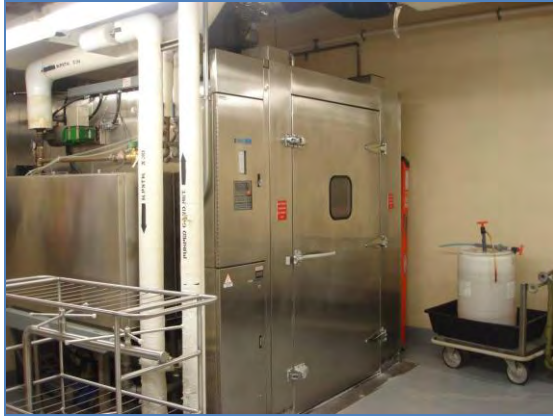
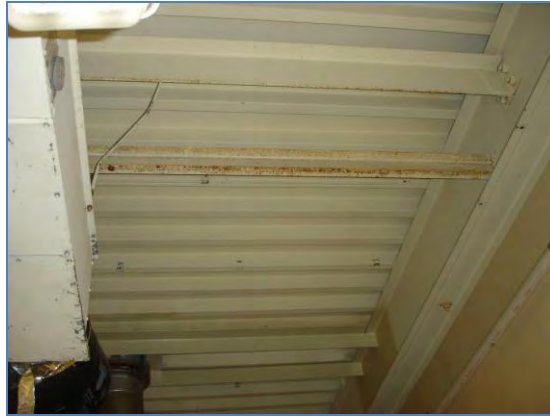
Above left, the VMU cage washer (Building 56) lacks an exhaust hood over the door to catch escaping steam. This can cause damage to interior finishes such as the corrosion seen in the roof metal deck of the cage washer room (photo at right).

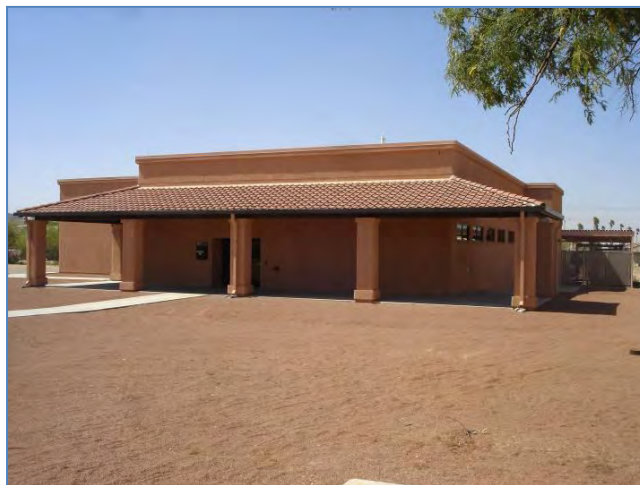
(At right) Building 78 is a beautiful new addition to the campus that provides modern, well designed laboratory space.

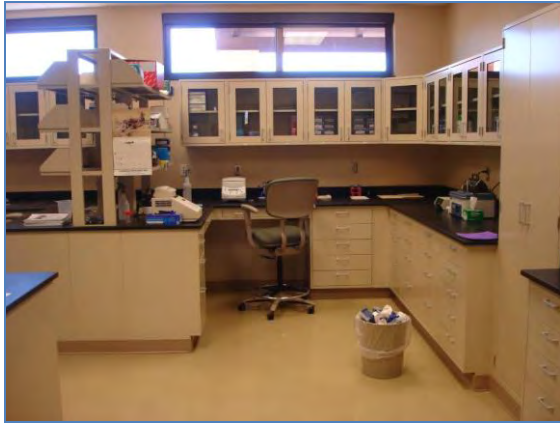
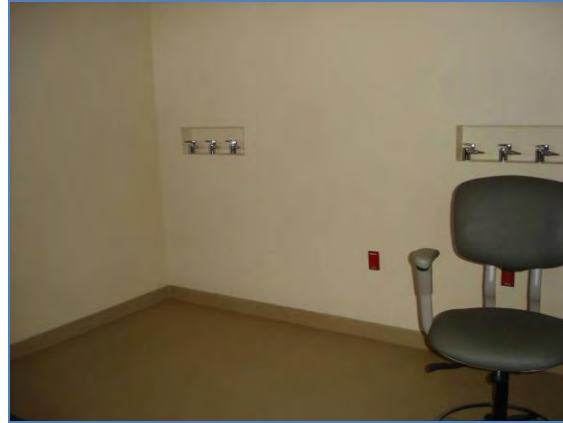
Above left, the new laboratory space in Building 78 is well designed. The photo at right shows the equipment bay in each laboratory that allows placement of needed equipment without creating crowded conditions.

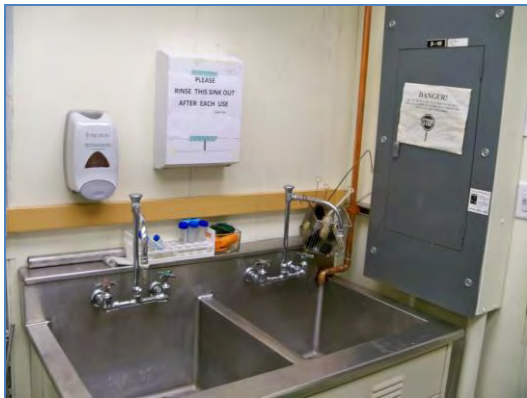
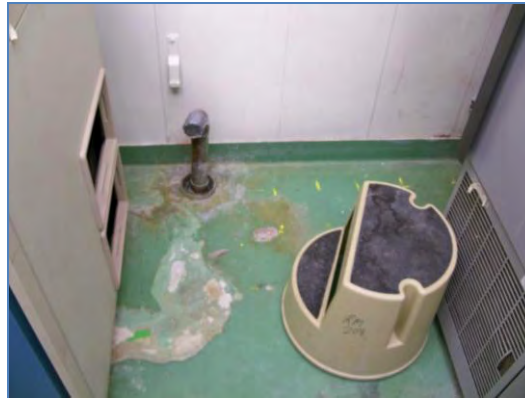
(Left) In Building 21, room 21-310, there is an electric panel over a sink. The photo at right shows damaged flooring in Building 21.

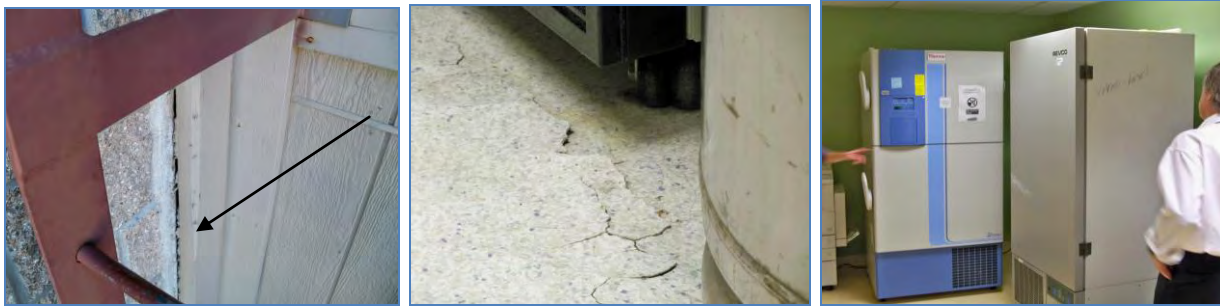
As shown above, Building 23 does not provide a proper environment for research. From left to right, evidence of significant structural deficiencies (elevator shaft is separating from the building); damage to flooring caused by thermal shock; and Ultra-low temperature freezers located in a corridor, not connected to emergency power and not monitored for failure (during the assessment, one of them had failed without anyone knowing).

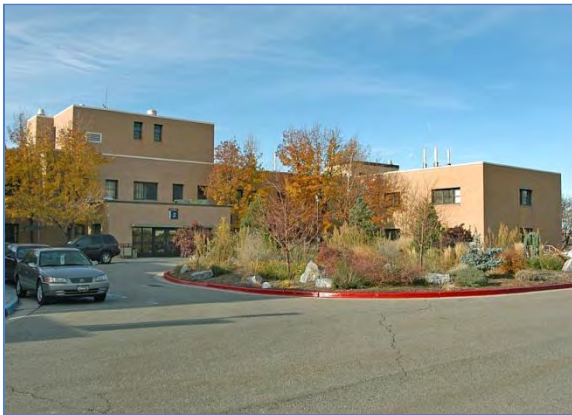
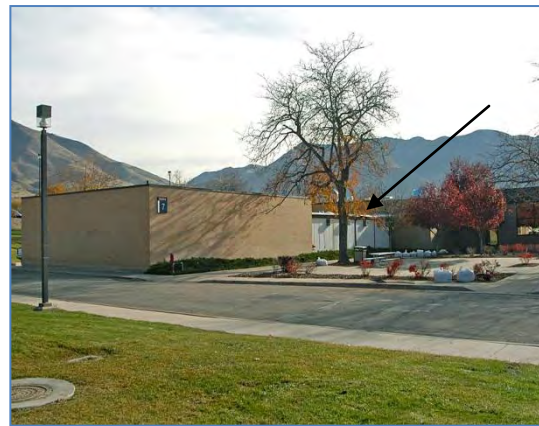
(Above left) Building 2 houses the newest laboratory space on the campus and provides the best opportunity for expansion of space. (Above right) Building 7, with its two component buildings joined by a modular structure (see arrow), is not an optimal environment for a VMU.

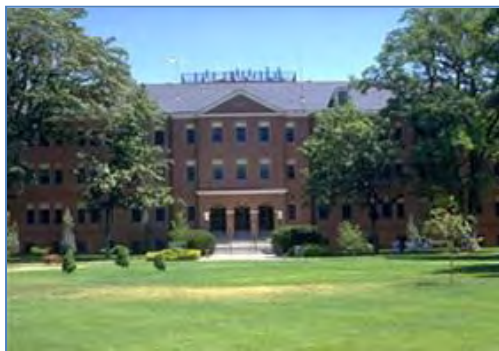
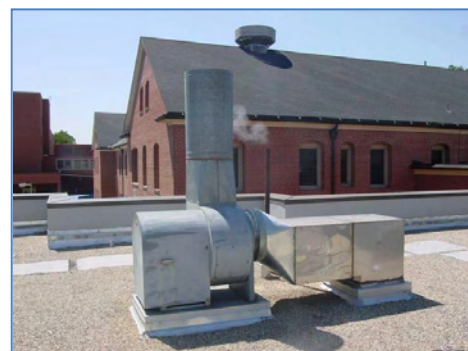
At left, Building 67 houses research laboratories in converted clinical laboratory space. At right, rooftop equipment on Building 109.

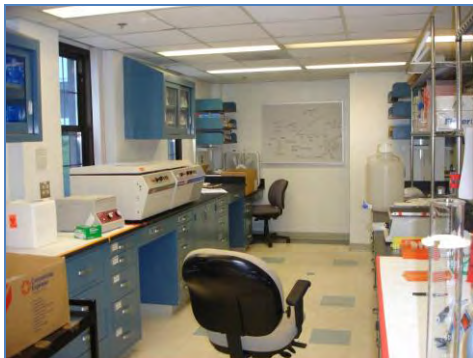
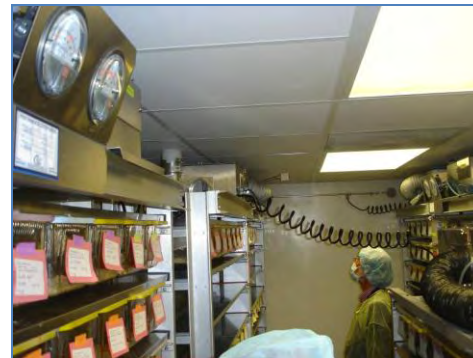
In Building 6, laboratories (left photo) and the VMU space (right photo) were retrofitted into a former dormitory that really is not suitable for research.

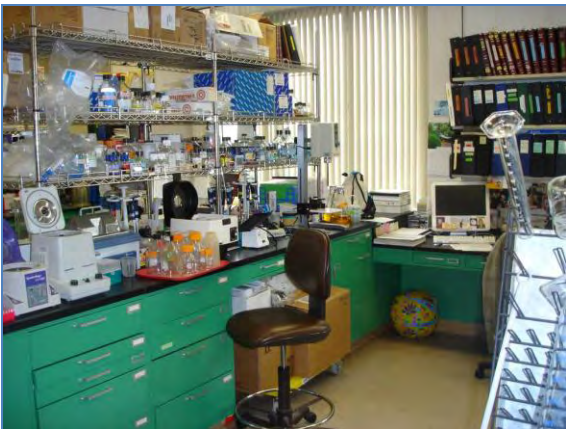
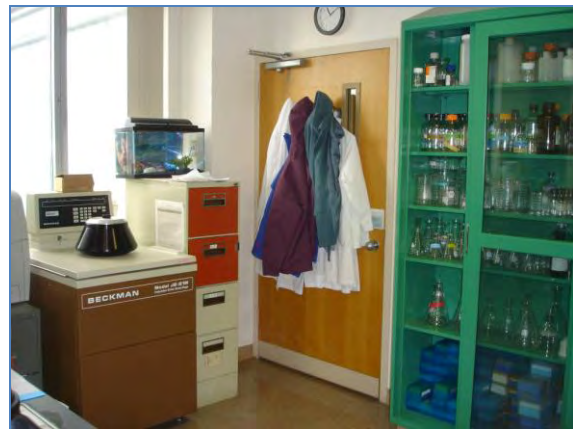
The photos above show two views of typical Building 101 laboratory space. Note the crowded conditions due to lack of storage and equipment space, sometimes impeding accessibility.

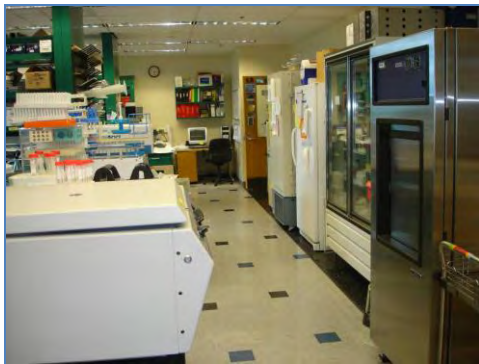
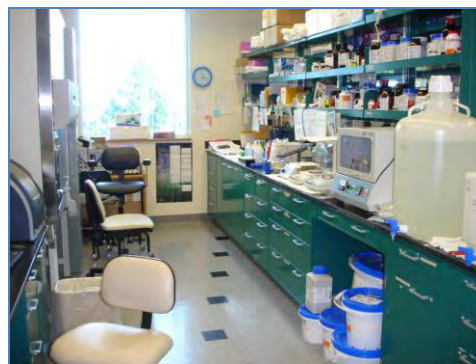
The photos above show typical laboratories in Building 103. Building 104 laboratories are shown in the photos below.

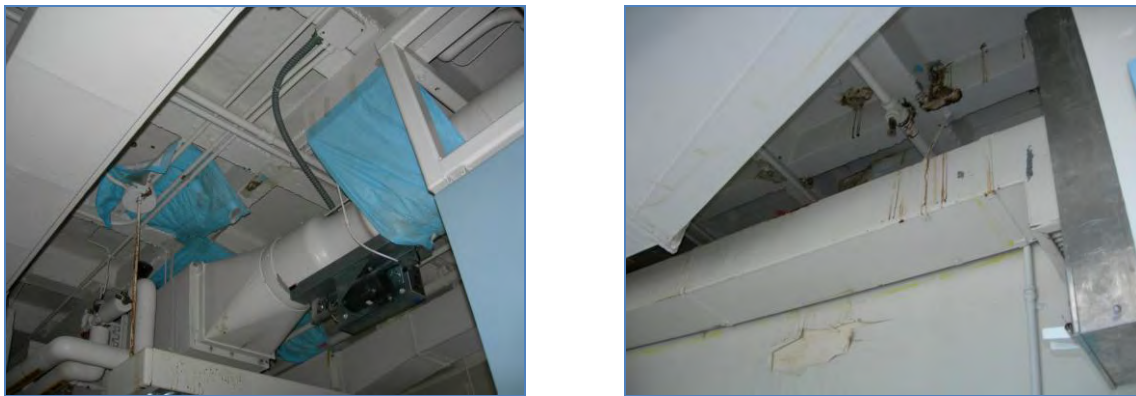
Above, leaks are prevalent in Building 1, due to roof leakage, mechanical equipment, and penetrations.

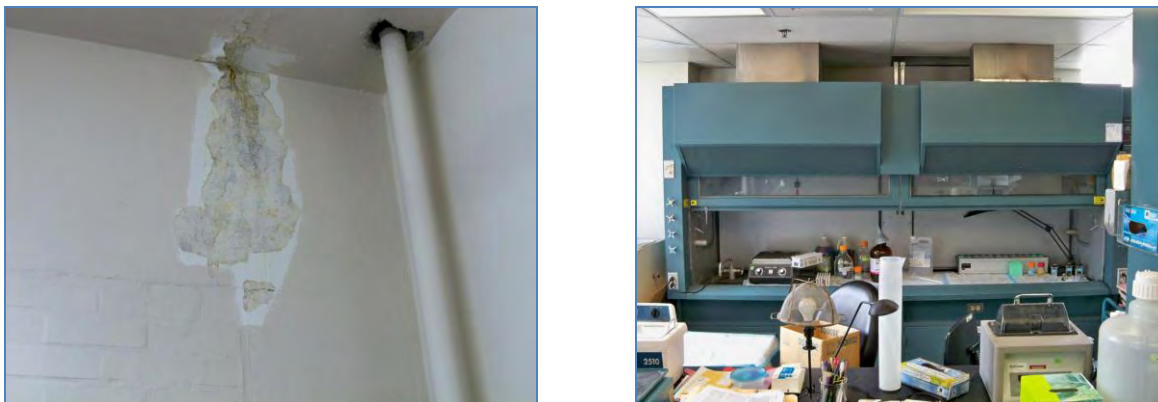
Below (left), Building 8 also has leakage problems causing damage to interior finishes. At right, an aging fume hood in a Building 8 laboratory.

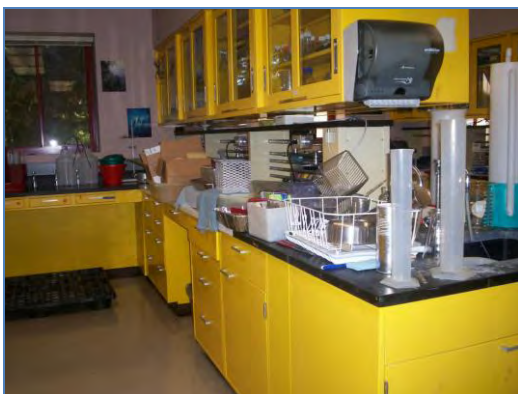
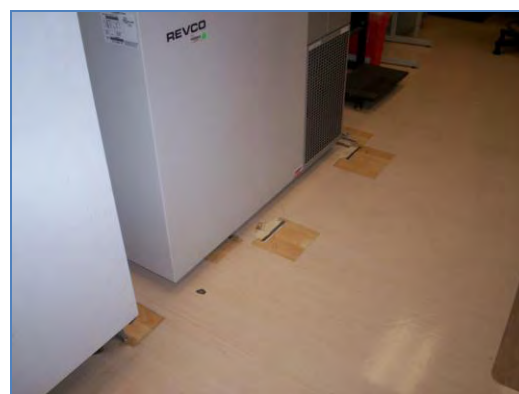
(Left photo) Typical laboratory space in Building R-1. (Right photo) Sheet vinyl flooring that has been patched.

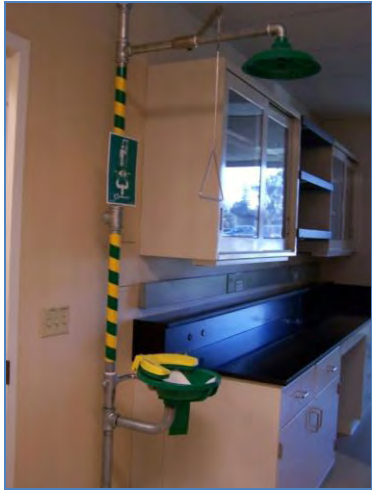
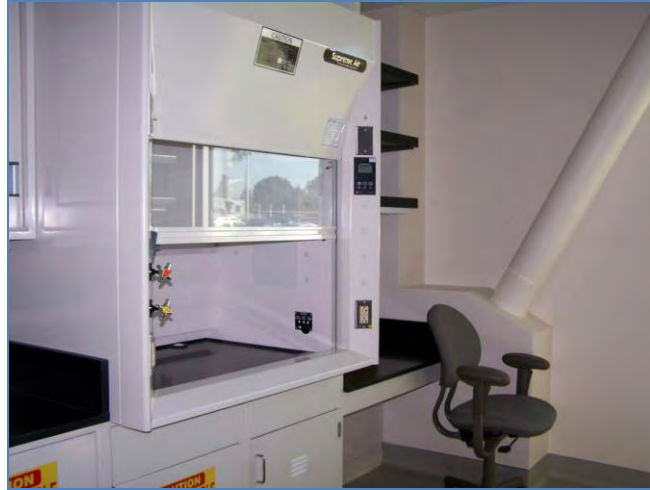
Photos above show the new laboratory space in Building 51. This high quality laboratory has a potential egress problem with the work station located next to the fume hood. In case of emergency originating in the fume hood, there is no secondary egress for someone who may be working at the desk area. A similar situation exists in Building 101 (photo, bottom left). At bottom right, the laboratories in Bldgs MB3/MB4 are in poor condition.

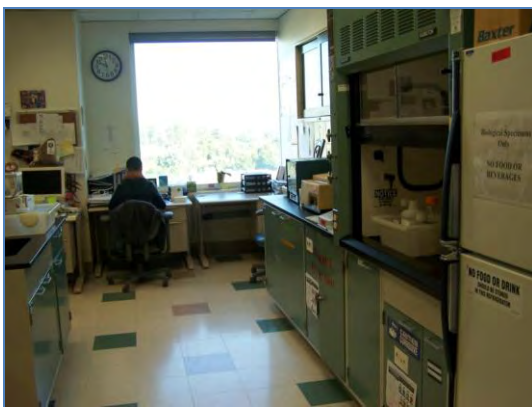
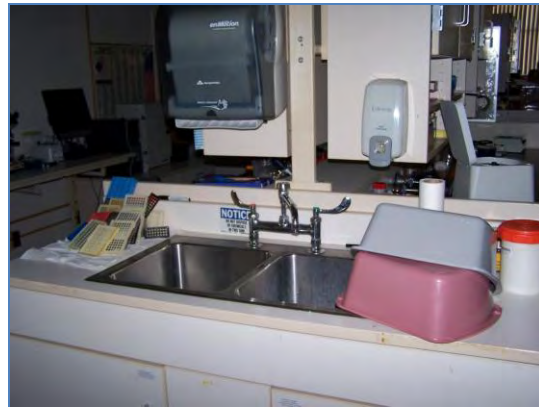
Building 100 is a five story building (four levels above ground, plus basement and penthouse) and Building 101 is a four story building constructed in 1997 and 1996, respectively to replace the former hospital and research buildings decommissioned after the 1989 earthquake. Research laboratories are housed on portions of the third and fourth floor of Building 100 and on the fourth floor of Building 101.

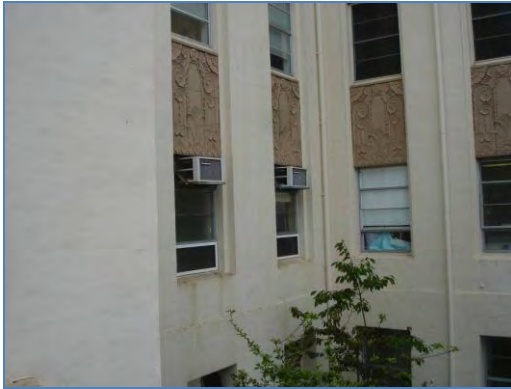
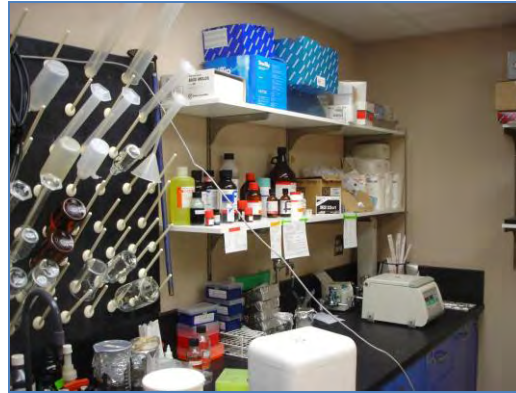
(Above left) Many buildings on the San Francisco campus are lacking central ventilation systems, as pictured here in Building 1. (Above right) A laboratory in Building 2/4/5. Note the lack of seismic lips on the reagent shelving above the casework.

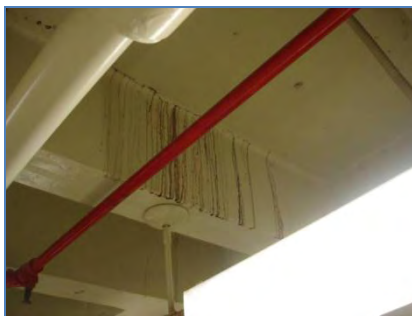
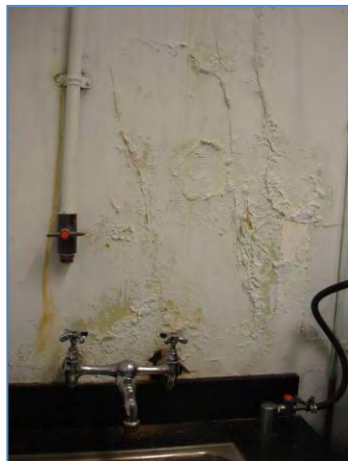
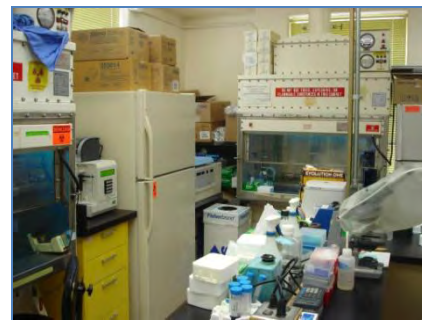
There is significant overcrowding throughout the laboratories in most, if not all of the buildings reviewed, primarily due to the presence of large equipment such as freezers and refrigerators within the laboratories rather than in common areas. The crowding is exacerbated by the inadequate structural spacing between laboratory benches and, in some instances, may not meet accessibility standards. Some equipment is also being stored in hallways, having the potential to block

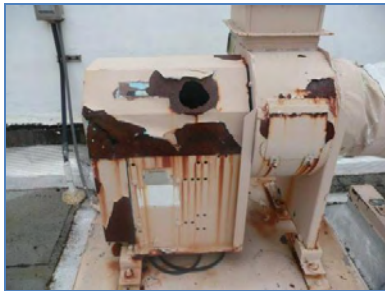
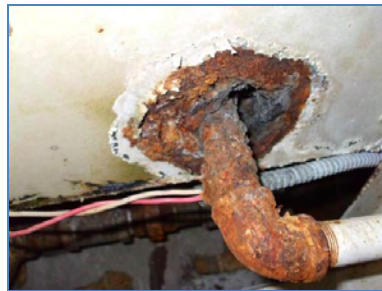
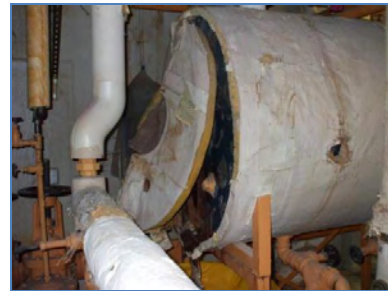
The coastal environment has been very harsh to equipment, as seen in the mechanical system components above.

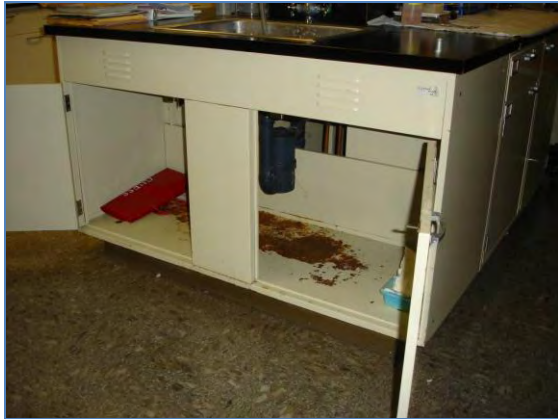
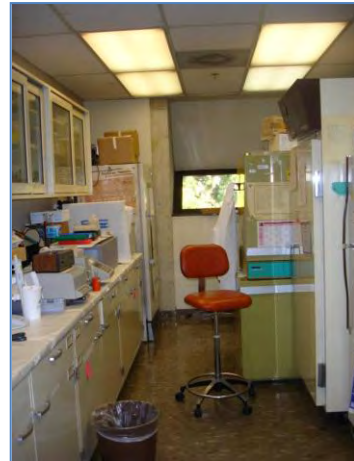
(From above left, clockwise): Corroded conditions beneath a laboratory sink; a typical laboratory with crowded conditions; ficus tree roots trying to grow into the building; and a typical laboratory sink.

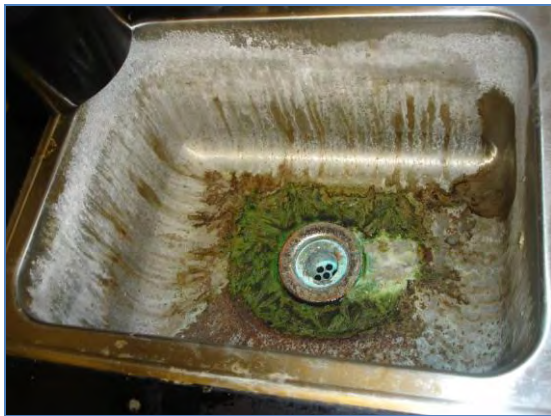
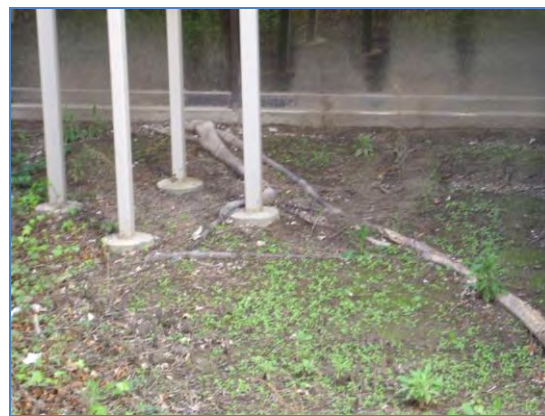
Most of the large equipment is in good condition, with the exception of the cage washer in the VMU which, although its internal system was recently overhauled, is corroding on the interior and the doors. There also is no sealing gasket at the door. The cold rooms were being replaced at the time of the survey.

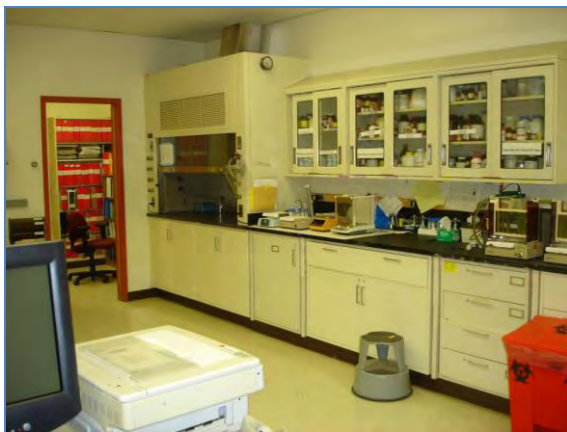
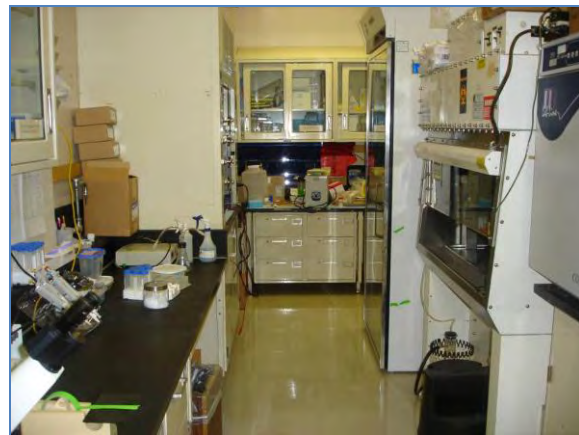
(Left photo) A typical laboratory. (Right photo) Accessibility in some laboratories is restricted.

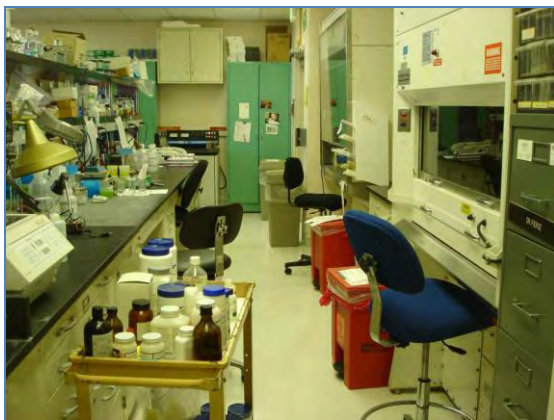
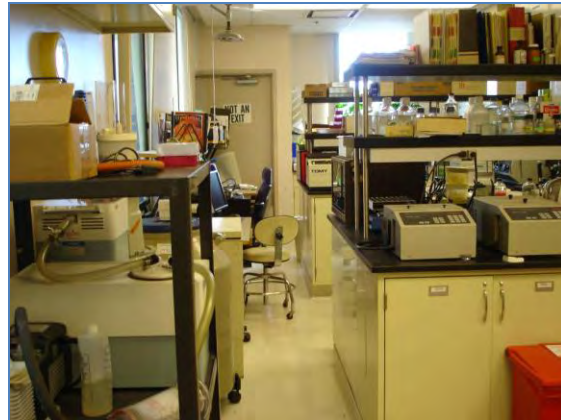
Examples of overcrowded conditions in research laboratories.

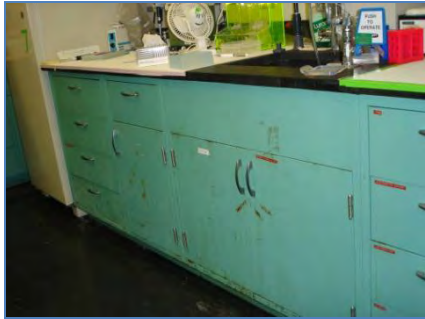
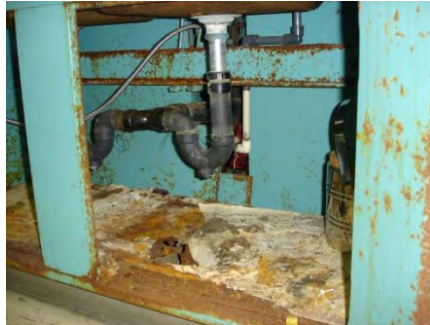
Examples of laboratory casework in poor condition.

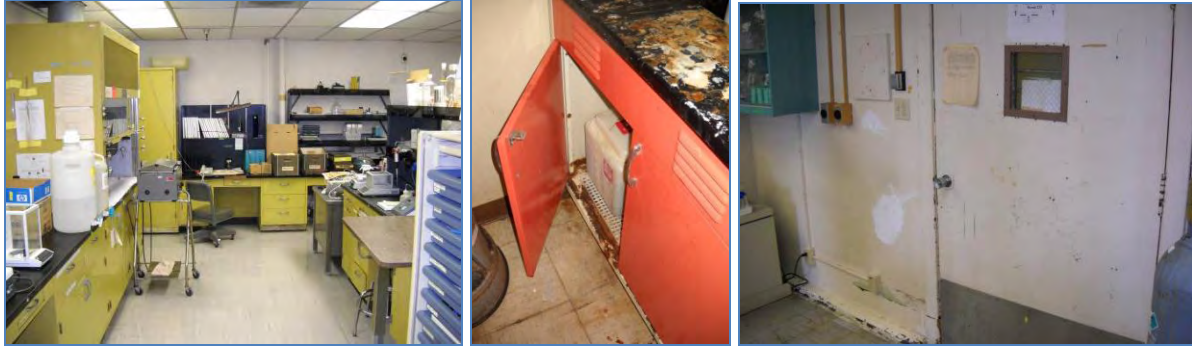
Conditions in Building 113

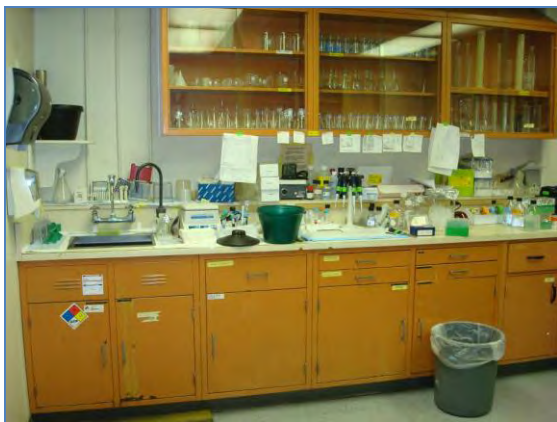
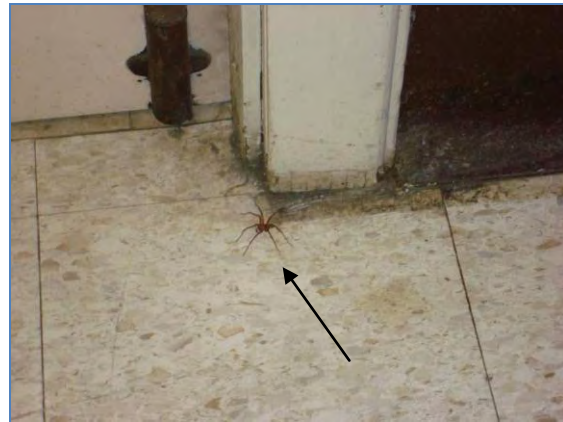
Conditions in Building 114 (note the spider at right)

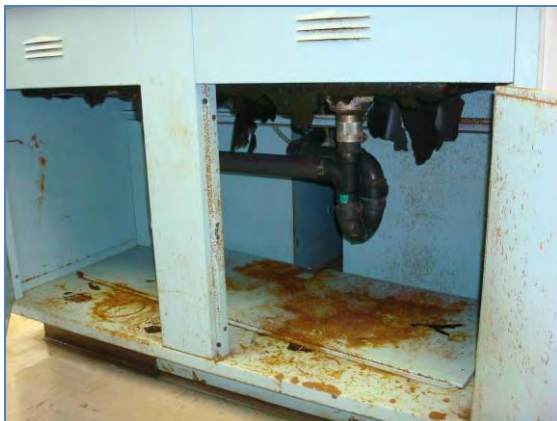
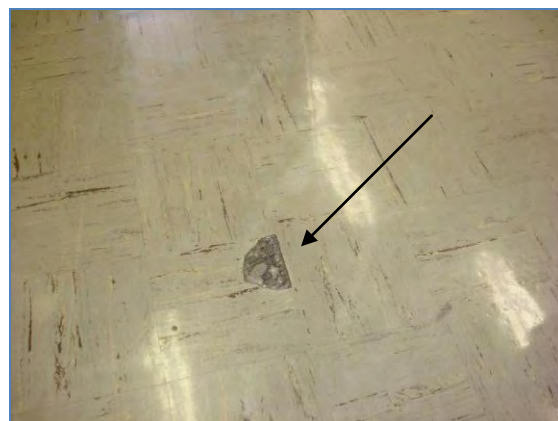
Conditions in Building 115. The photo at right shows chipped asbestos tile.

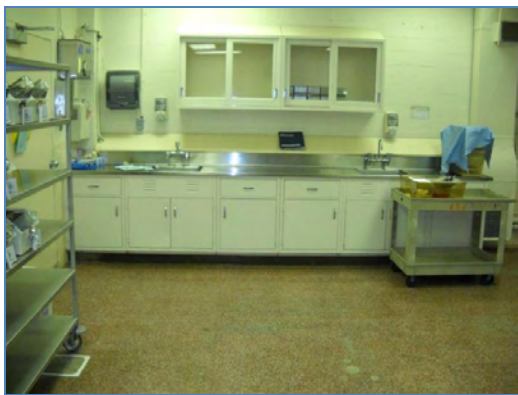
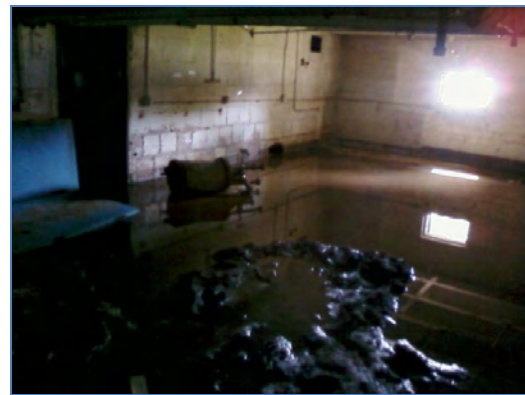
Conditions in Building 117 which houses a portion of the VMU. Note the water standing in the basement in the photo at right. (The basement houses mechanical equipment, not animal research space.)

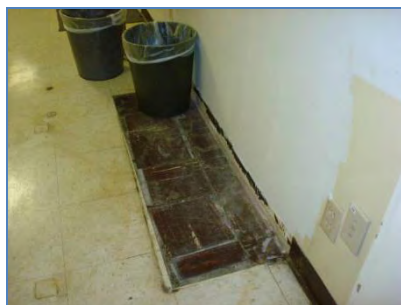
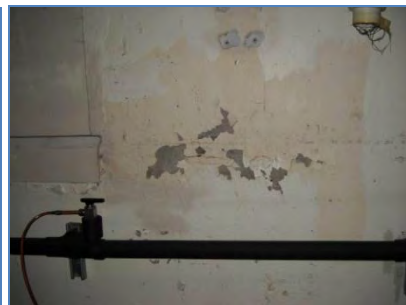
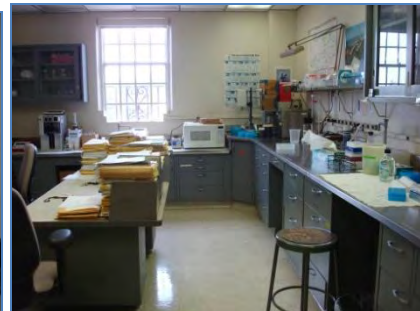
From left to right, damaged asbestos flooring in Building 210; a damaged wall finish in Building 212; and a laboratory in Building 258.

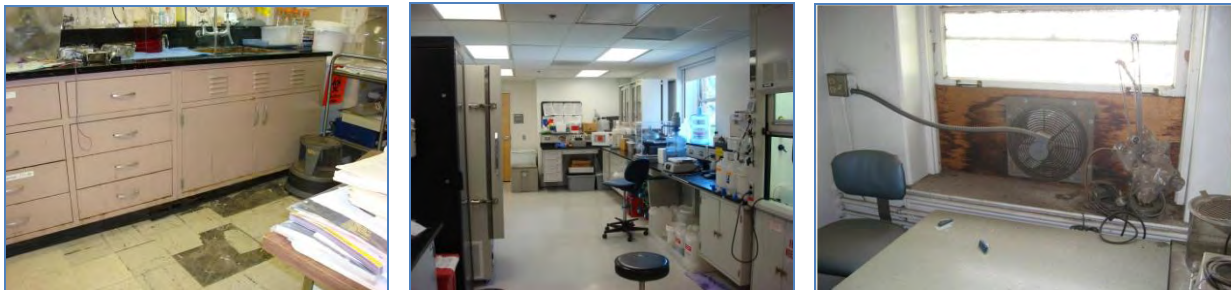
Left to right (above), a Building 1 laboratory with significant damage to asbestos flooring; a typical laboratory in Building 7; a window mounted "exhaust" fan, Building 62.

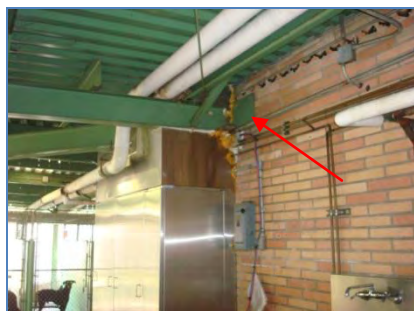
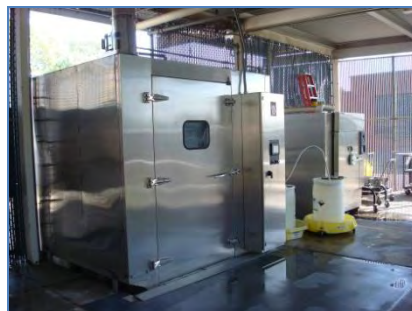
Left to right (below), part of the Building 47 cage washer is outdoors (the arrow is pointing to a bird's nest); Building 103 also has an outdoor cage washer.

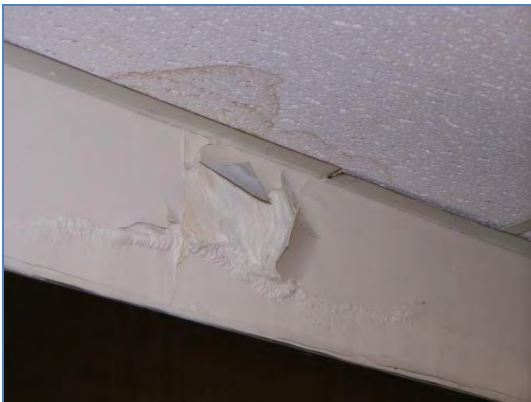
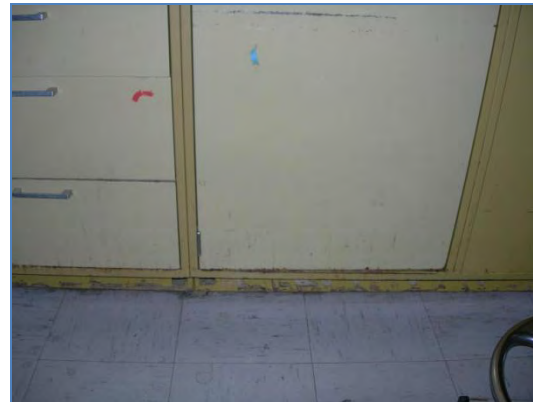
Above, deteriorated wall and ceiling finishes (left) and casework (right) in Building 1 laboratories.

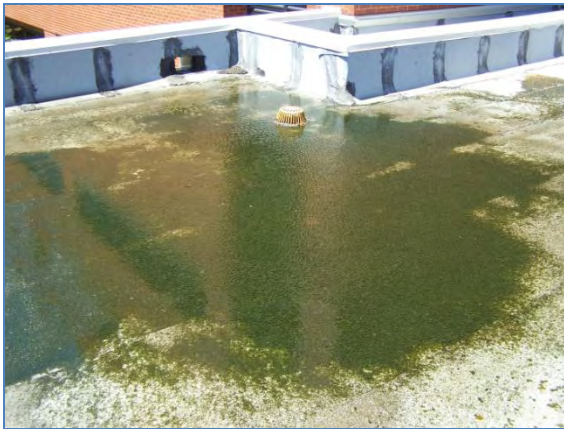
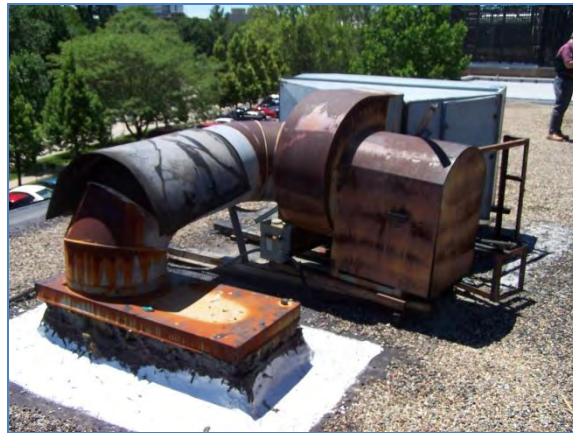
Bldg 2: ponding water on the roof (left) and deteriorating exhaust equipment.

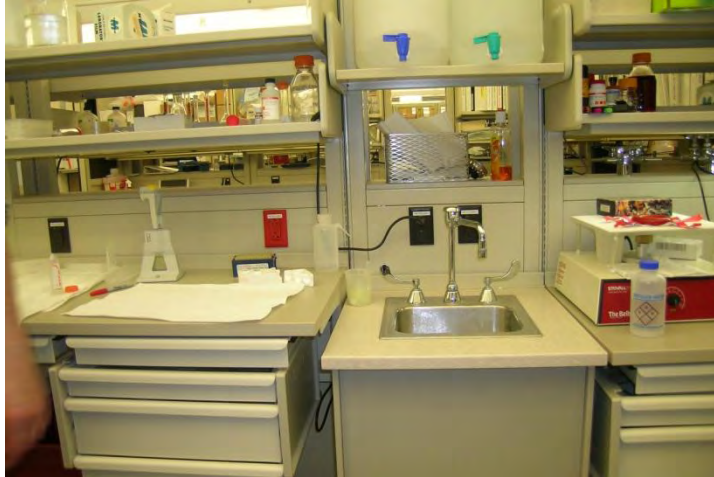
This casework (pictured in Bldg 40) is typical of the laboratories in both Buildings 40 and 41. Note the receptacles over the sinks are properly ground fault protected.

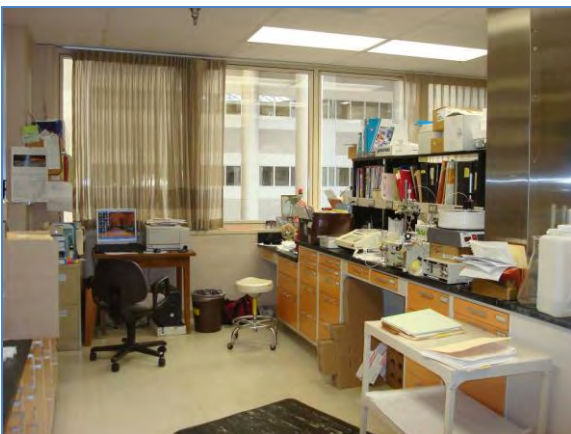
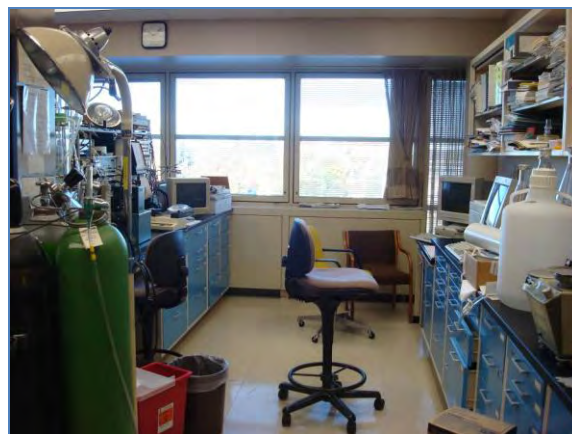
Two examples of Building 70 laboratories.

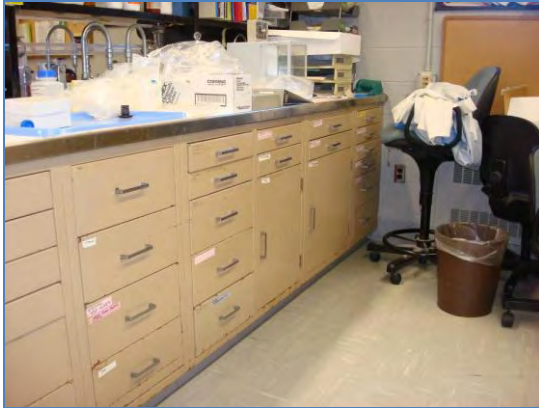
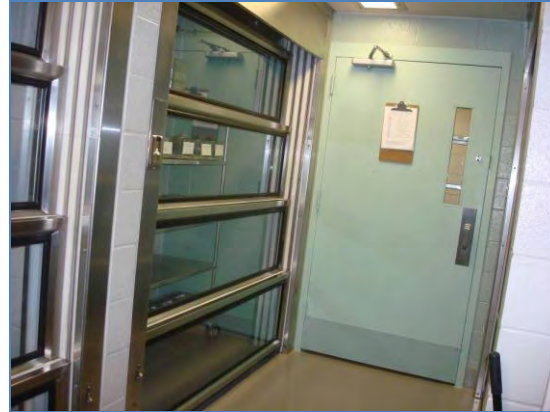
(Left) A laboratory in Building 49. (Right) Animal housing booths in the VMU.

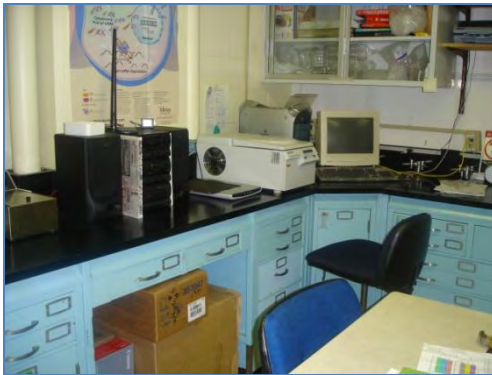
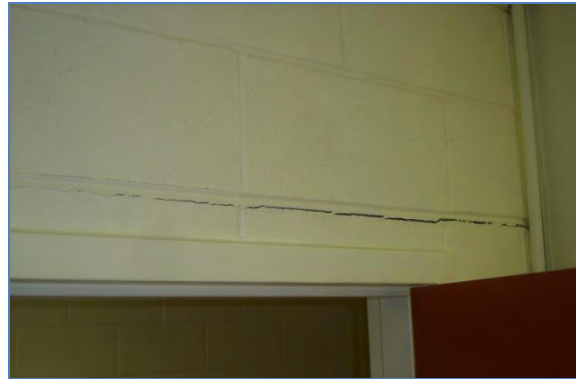
(Left) A typical laboratory in Building 15. (Right) Cracks were noted on interior walls throughout the space.
